EQUIPMENT REPAIR REPORT

Our Reference: Sales order #5000005320

Subject: Gould's AC - SRL-C Slurry Pump 14x12-29 Discharge Bottom Left When viewed from drive end

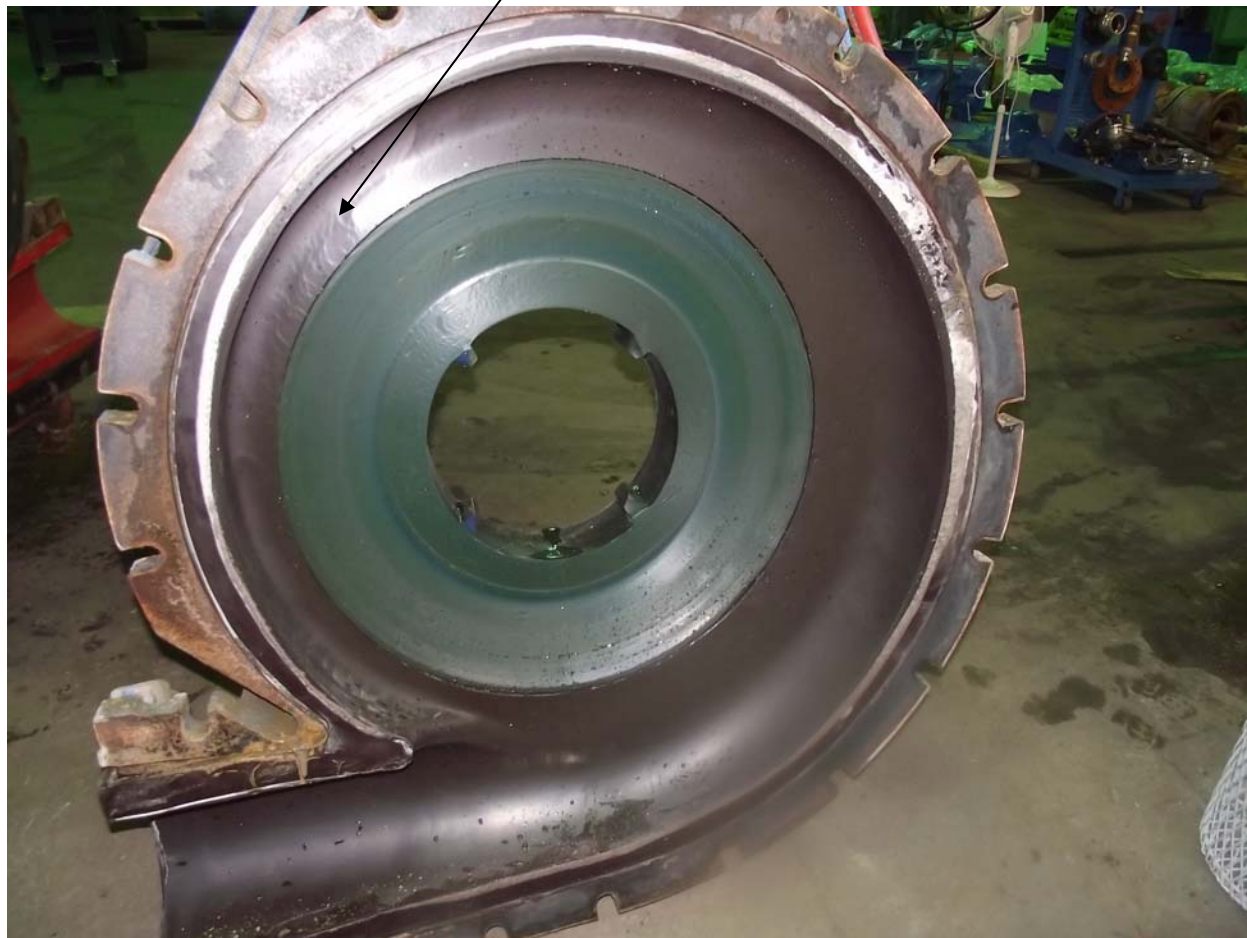
The suction liner pictured below is new from September 2009 and has stood up well in the slurry. For the purposes of comparison we have presented the photos of the old suction liner prior to the 2009 replacement.

This is the photo of the suction liner. This liner was replaced in September of 2009. It has held up well.

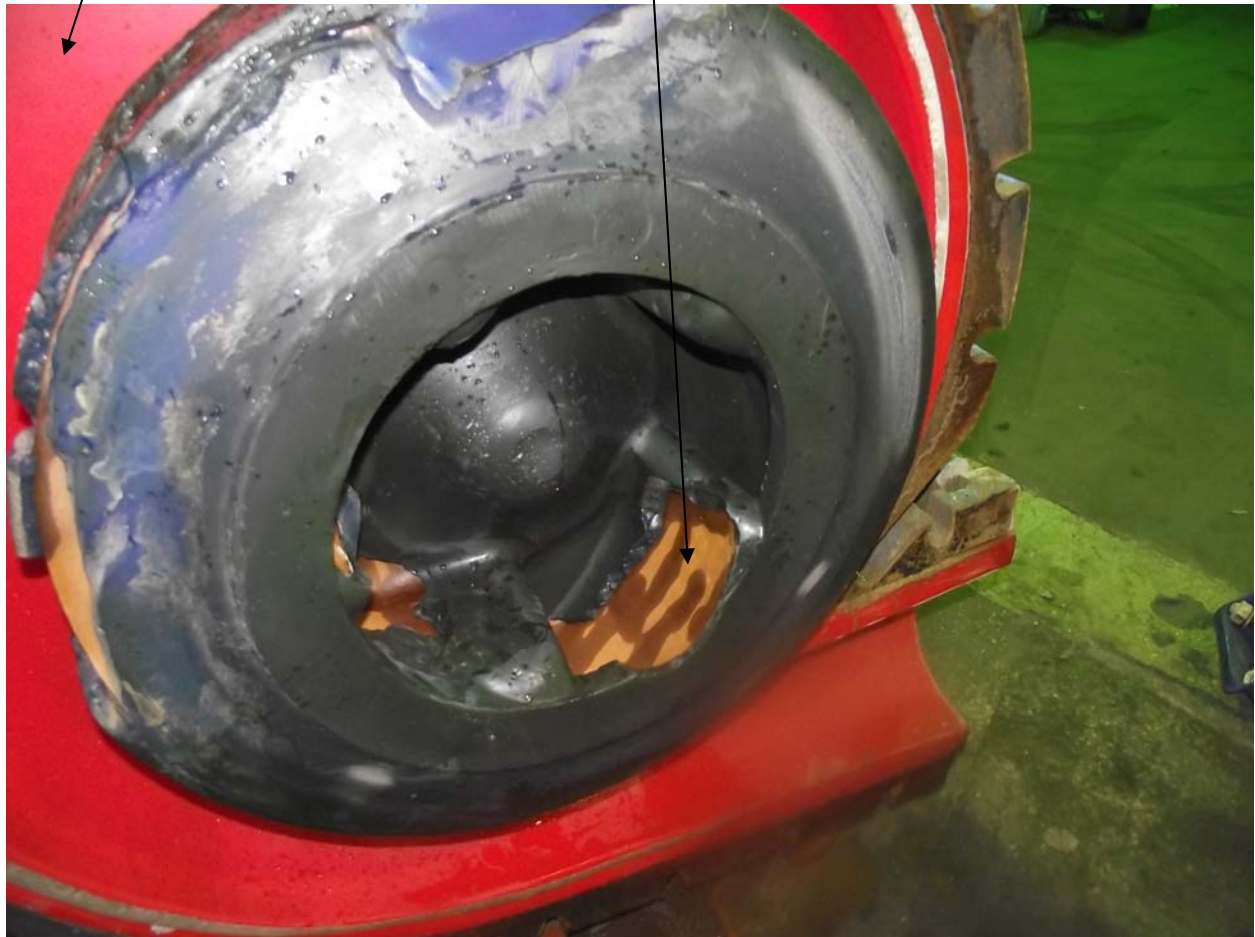
The gland side liner pictured below was replaced in September of 2009 and it also has stood up well showing little signs of wear.

The impeller pictured below was worn in September of 2009. It was usable then but now requires extensive repair.

The gland side liner was also replaced in September 2009 and is in good condition. However the impeller which has portions eroded away will required repair.

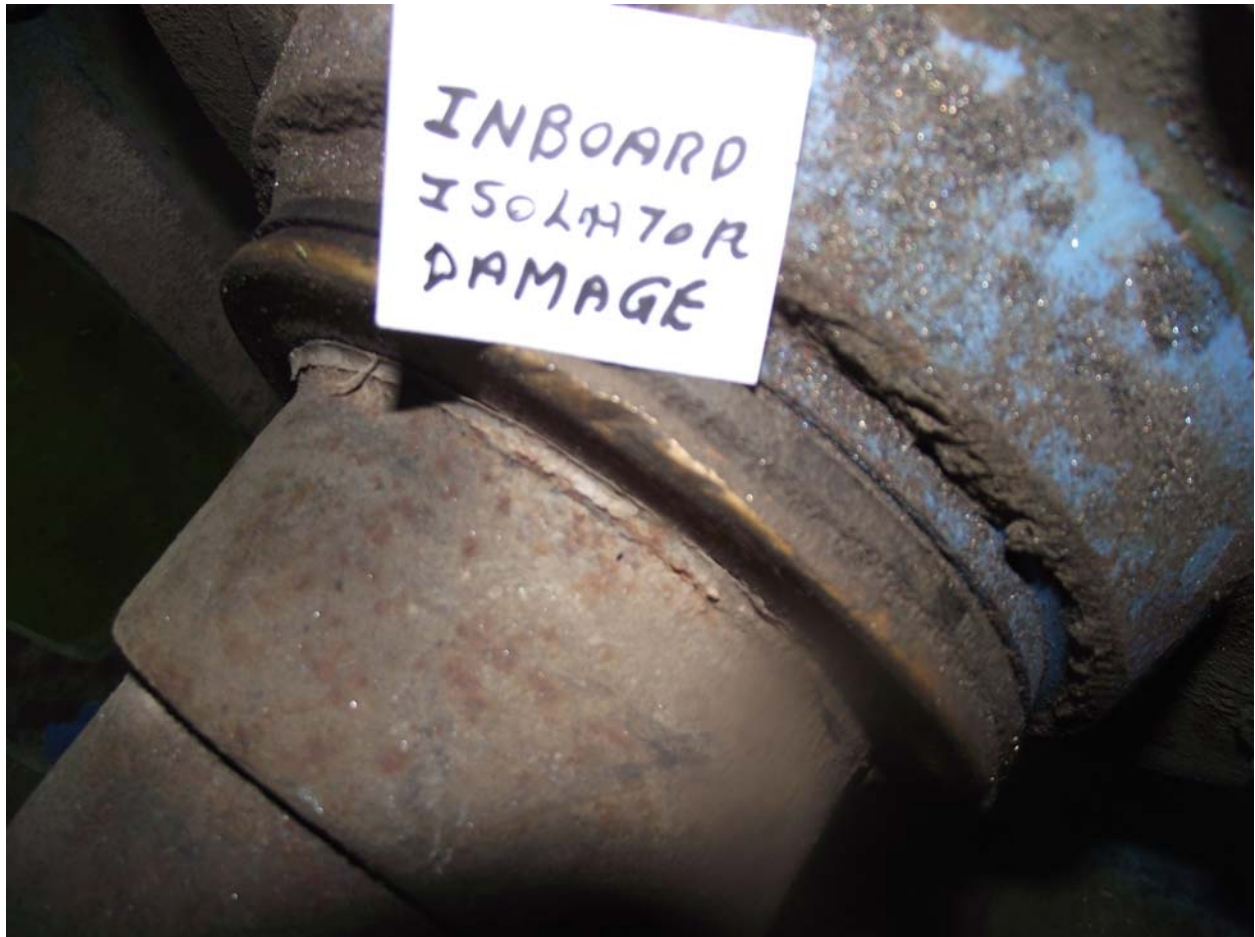
The inboard isolator is damaged and requires replacement in order to affect a proper repair and to prevent the oil from being contaminated in operation.

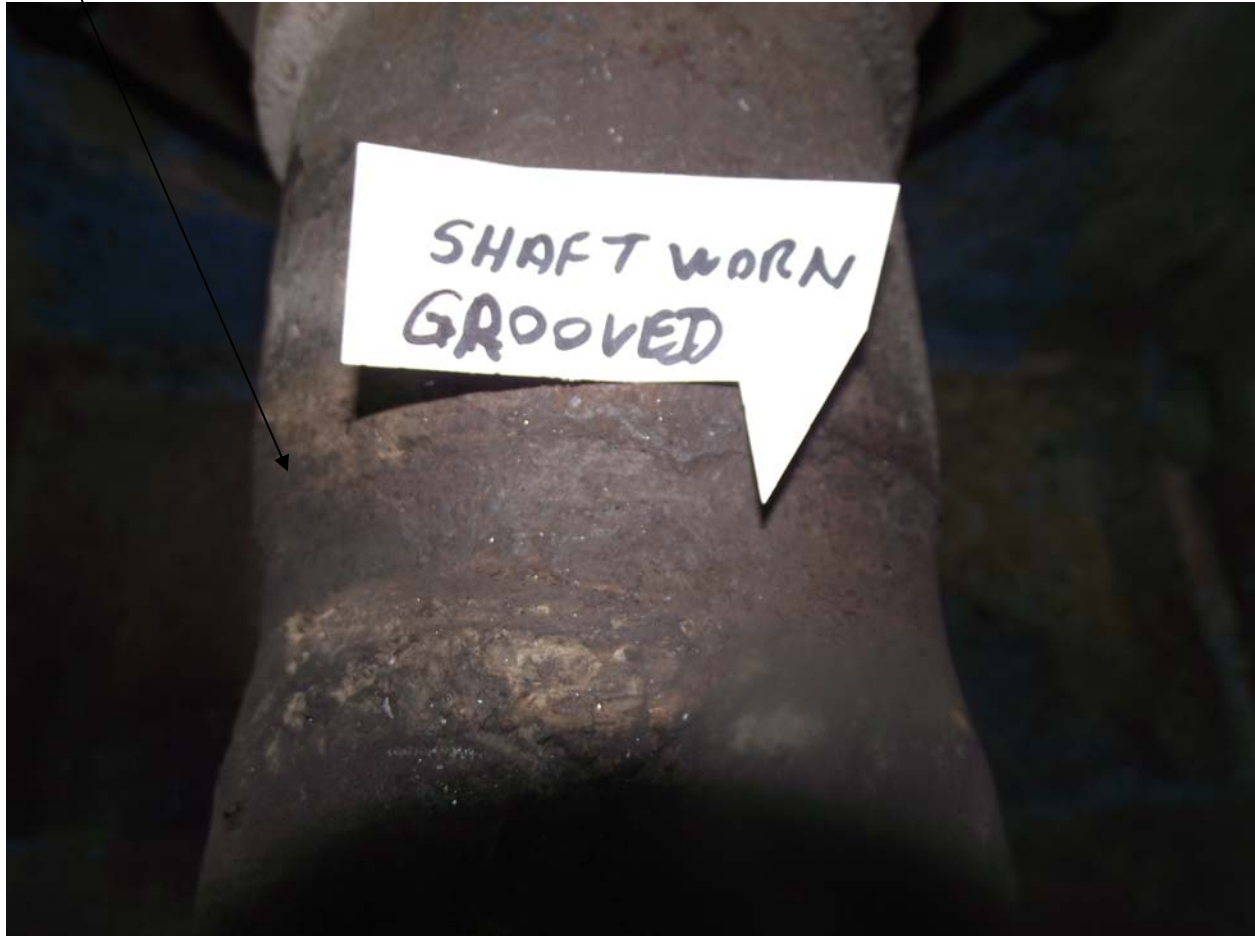
The pump shaft sleeve and shaft have extensive wear in the area of the packing. The shaft requires replacement along with the sleeve. The sleeve will be hardened to resist the abrasion and the stuffing box will be sealed with Tom-Pac as part of a sound repair.

The shaft broke in operation in 2007. It has eroded to the point that shaft replacement is required this year. The depth of the wear is in excess of 1/4" (1/2" total on a 4" diameter shaft).

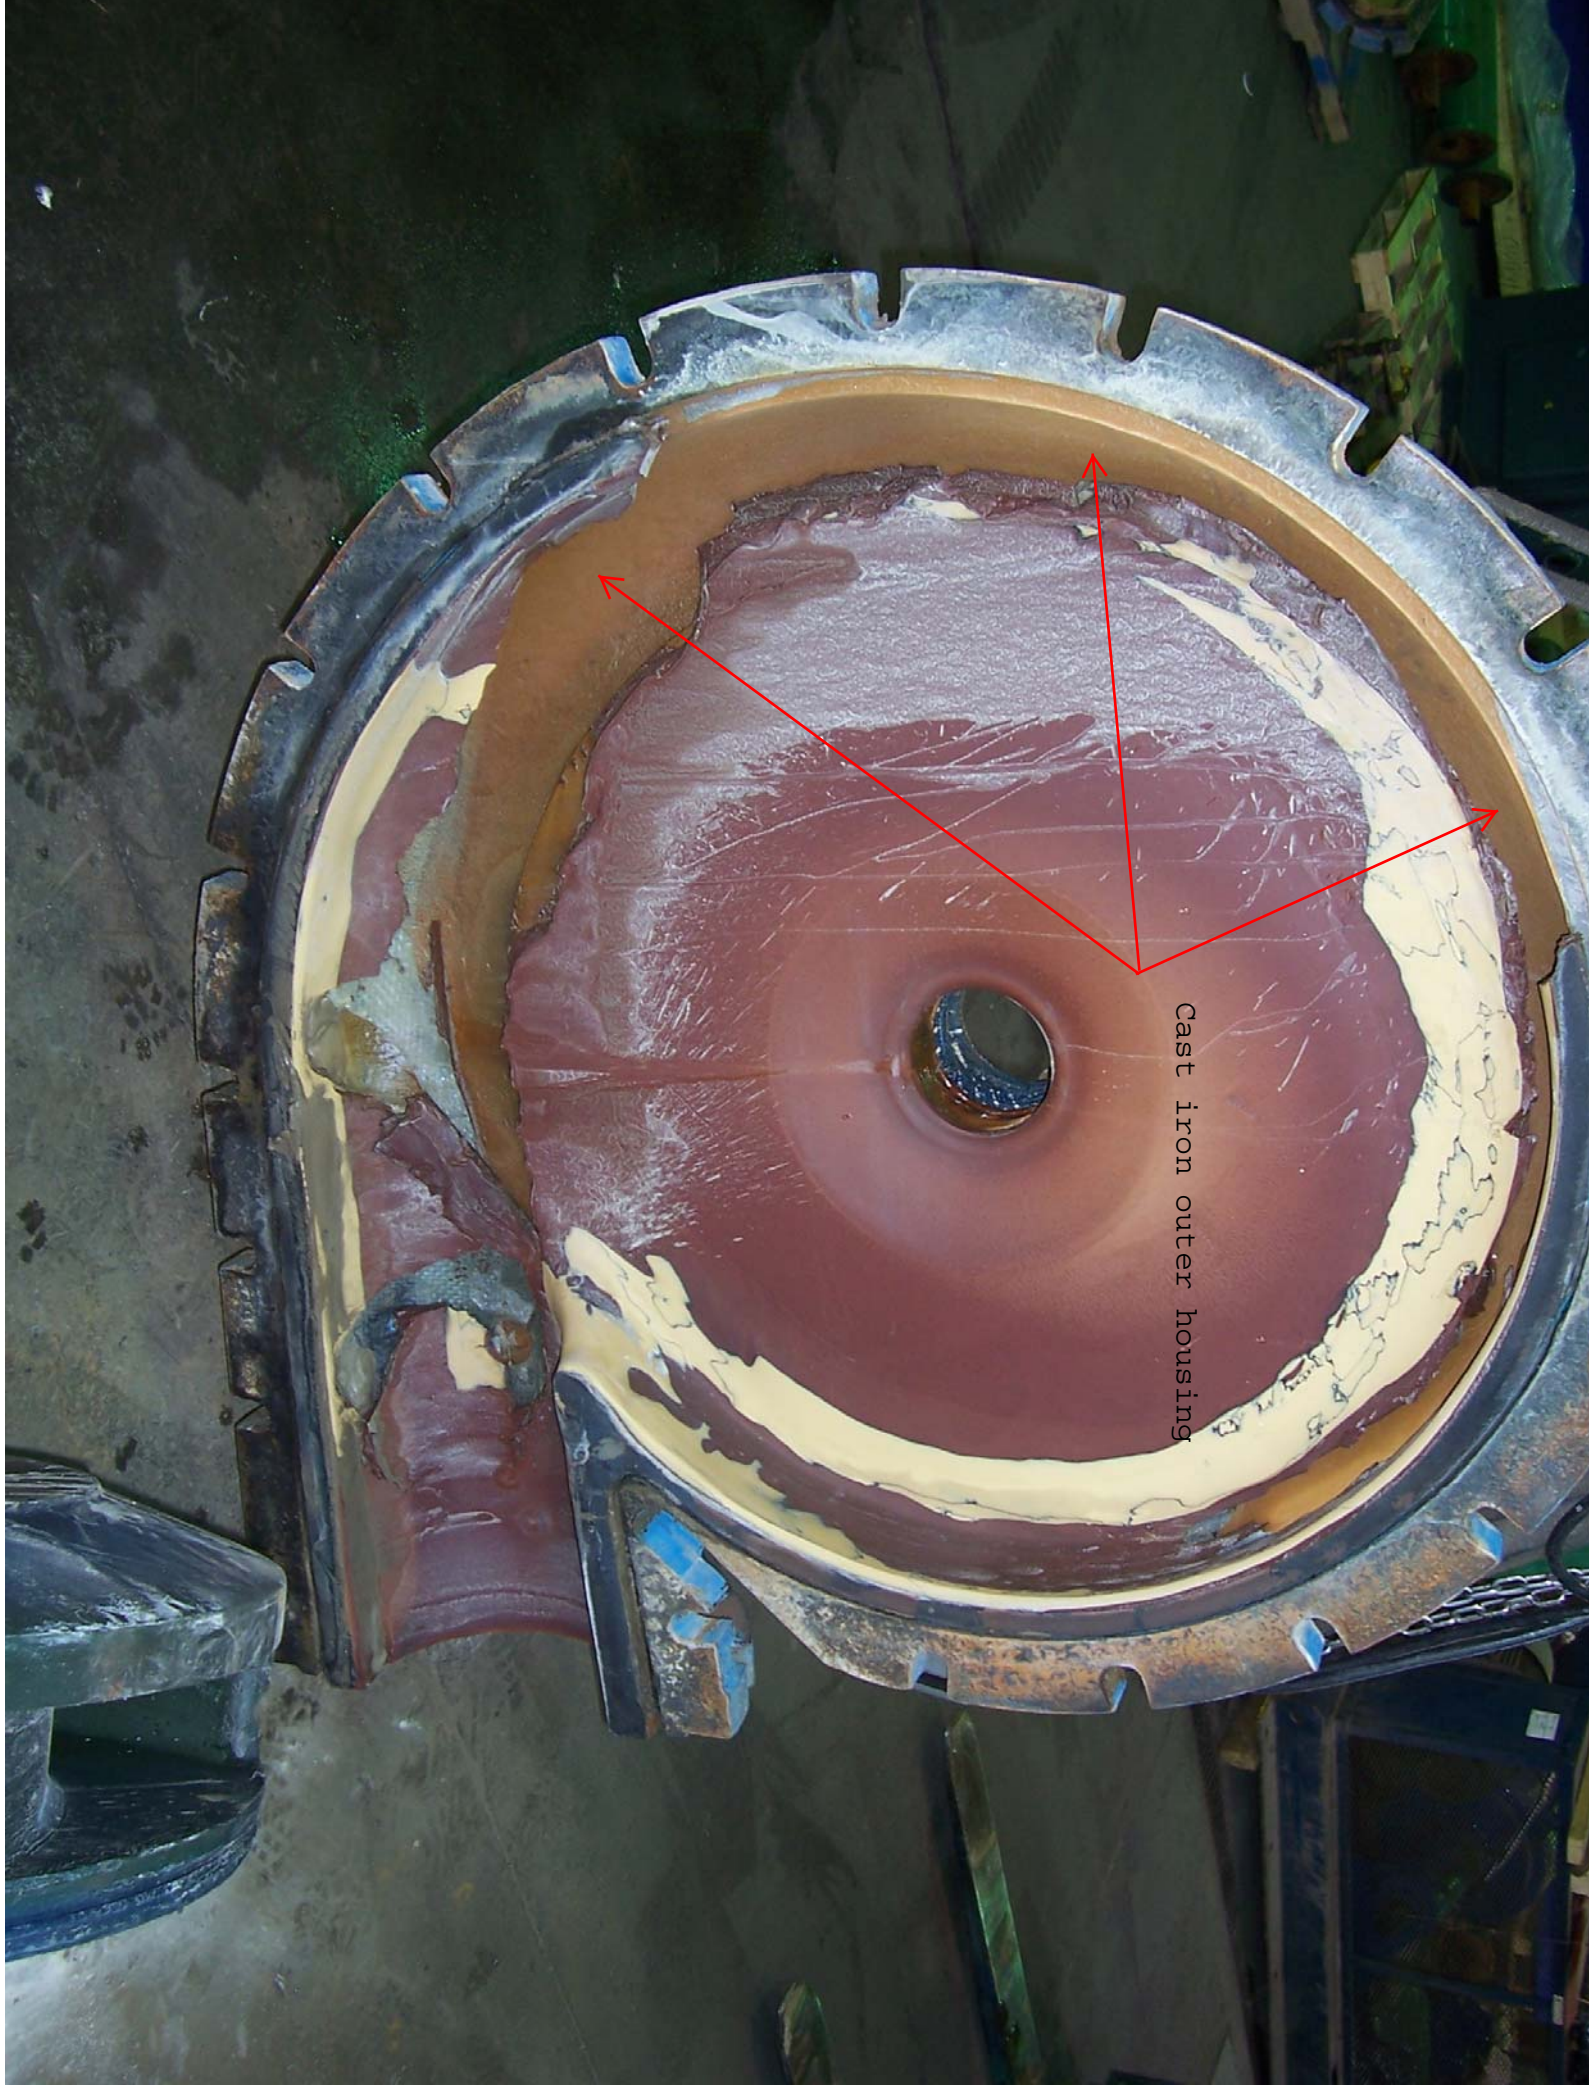
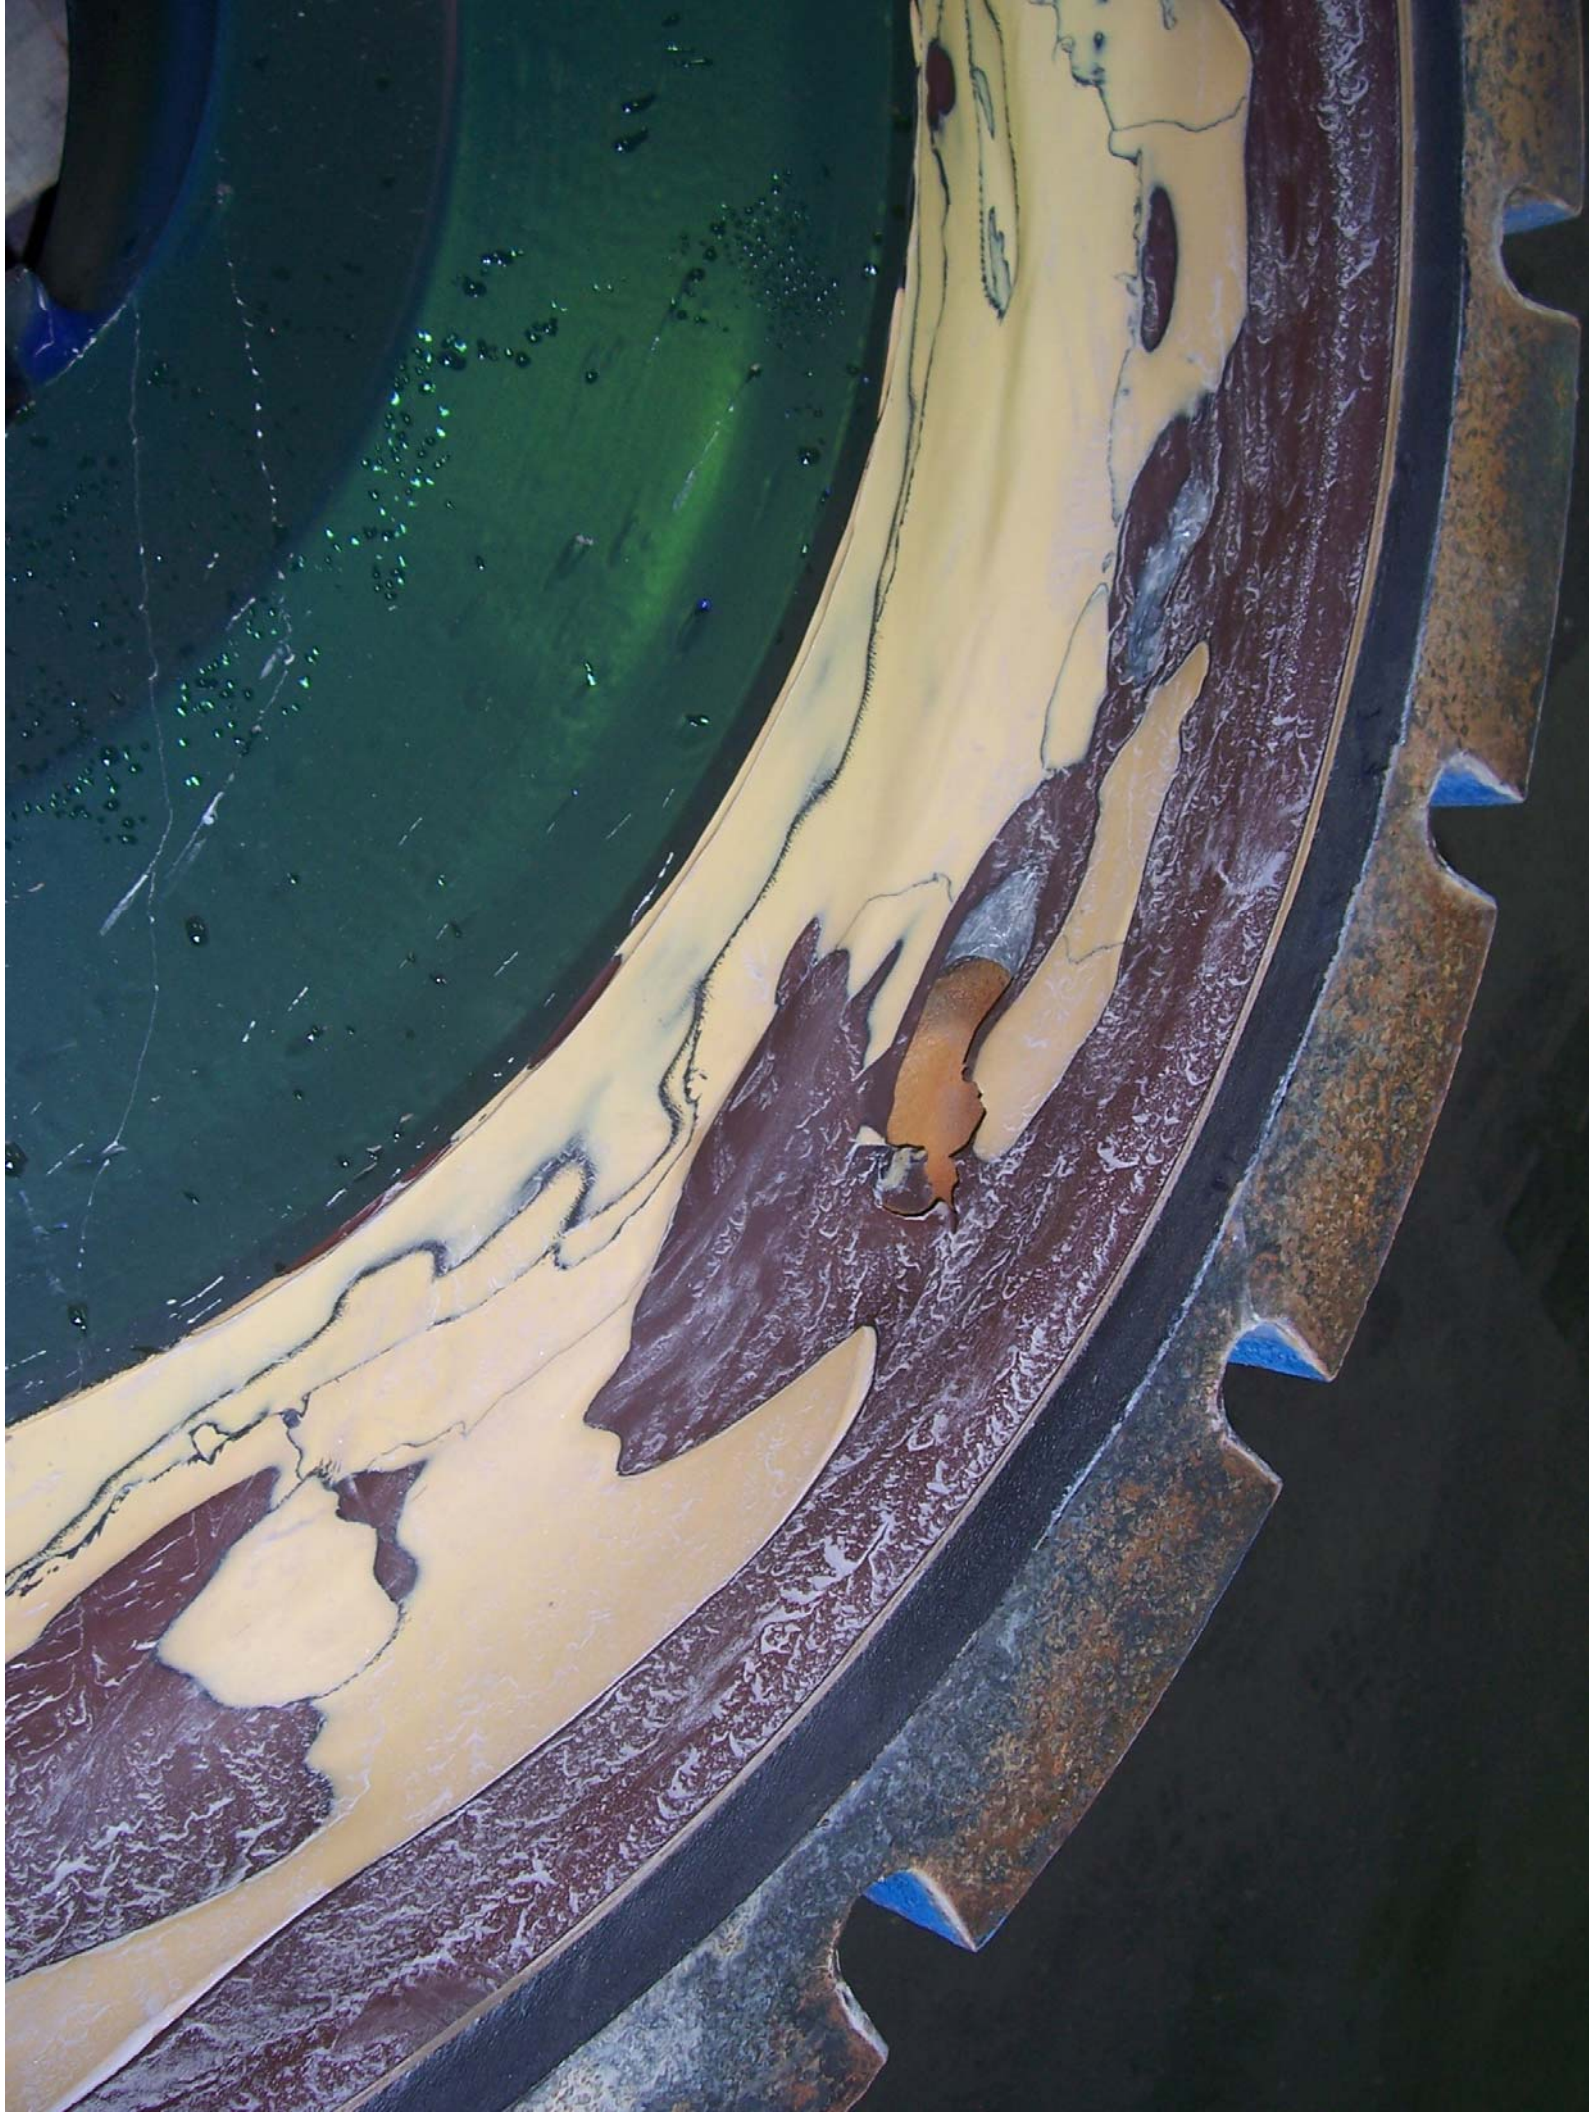
Cast iron outer housing

Small tear

Urethane suction liner in very good condition, running for almost two seasons.

Small worn hole on the front liner.

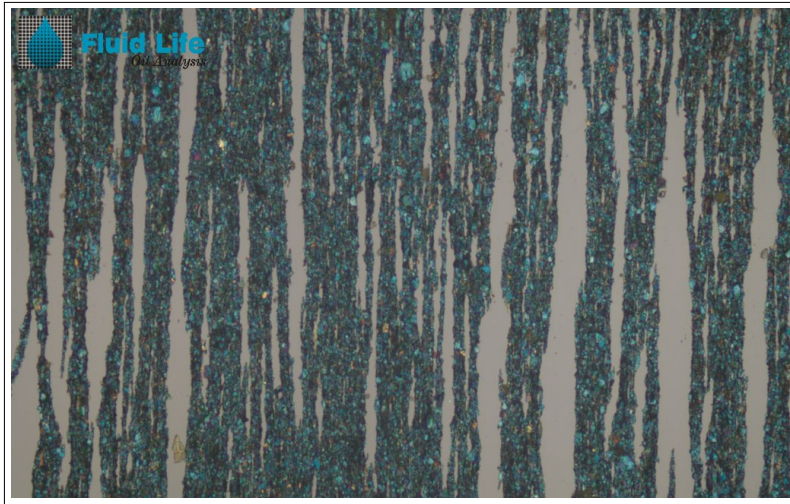
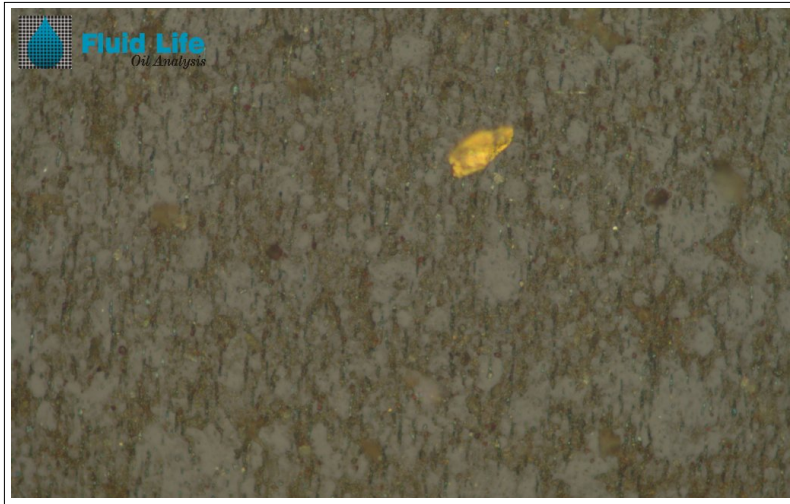
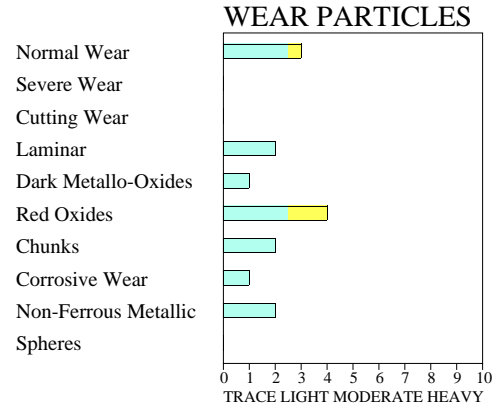
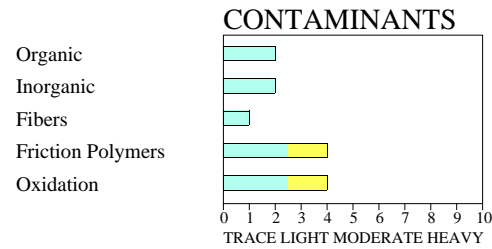
Ferrography results are reportable.

Most metal particles are low alloy steel showing rubbing/sliding and laminar wear (up to 18 microns). Trace medium alloy steel showing laminar wear.

Reportable levels of red oxides and friction polymers. (indicates water contamination.)

Slightly elevated levels of copper/copper alloy showing laminar wear up to 29 microns.

Slightly elevated levels of dirt/dust.

Check for sources of outside contamination.

Continue to monitor. Some tests have been performed at another Fluid Life lab. If you have any questions, please call the lab.

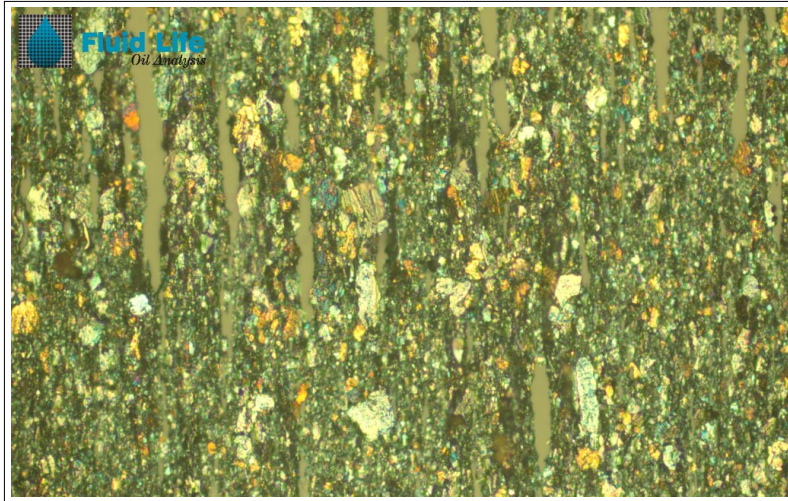
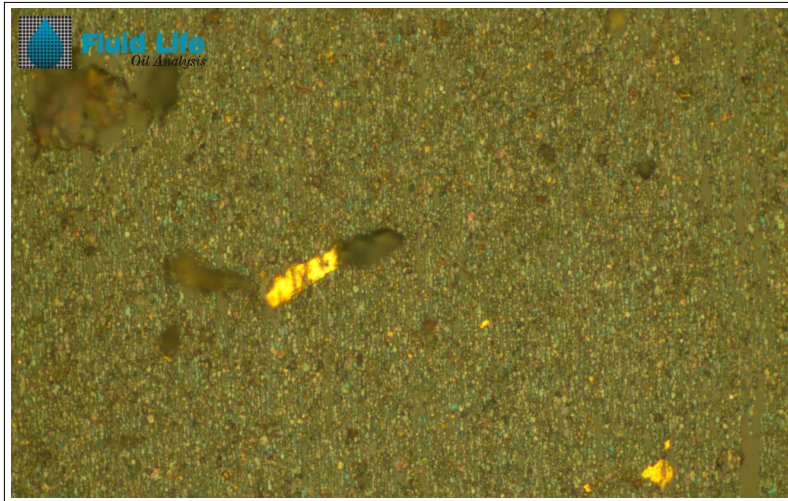
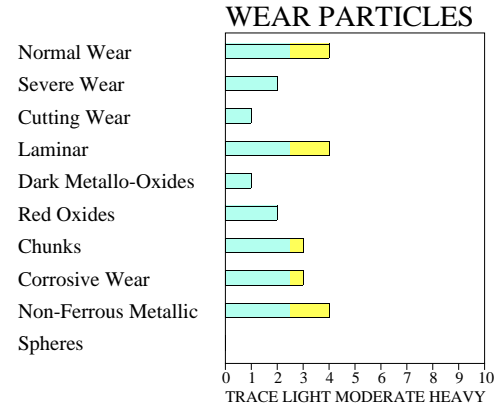
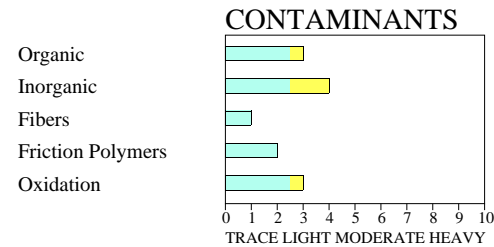
Ferrography results are unacceptable.

Most metal particles are low and medium alloy steel showing rubbing/sliding wear and laminar wear up to 75 microns. Traces of cutting wear.

Elevated copper/copper alloy up to 33 microns.

Traces of red oxides and elevated dirt/dust.

Check for sources of outside contamination and for sources of copper/copper alloy.

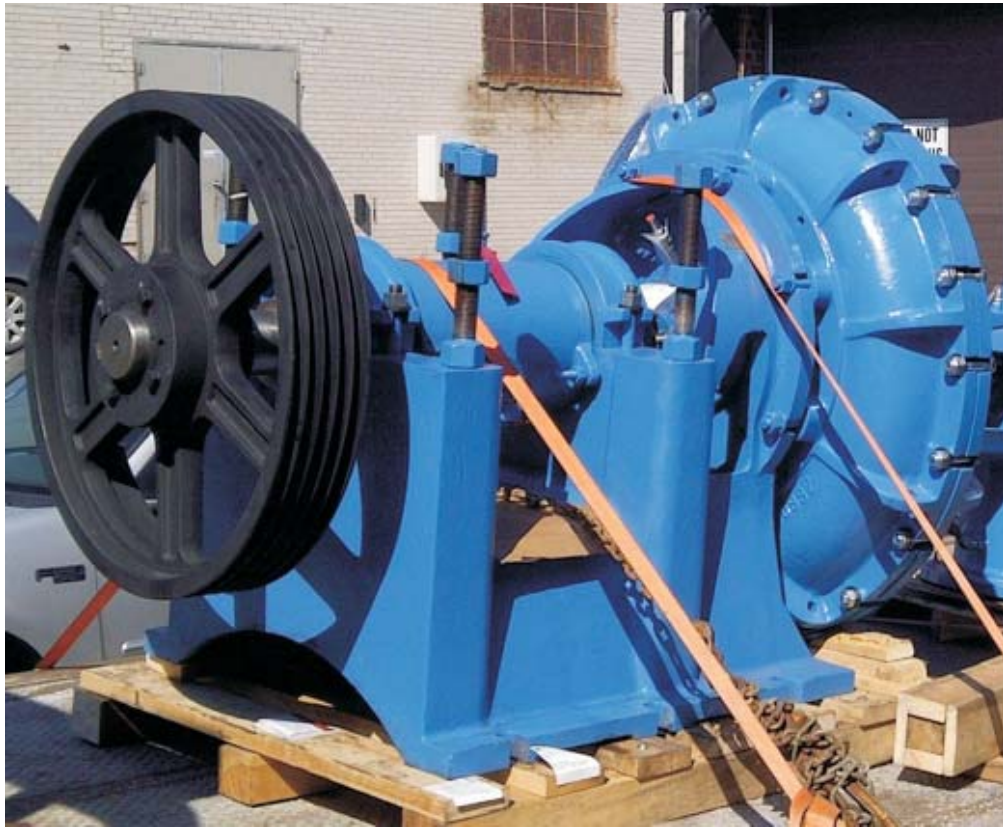
Completed repair loaded for shipment.
