## EQUIPMENT REPAIR REPORT

**Our Reference:** Sales Order #5000003764 Ref: 071459

**Your Reference:** Pump # 2 Circulating Tank

**Subject:** Gorman Rupp Model T3A60S-B/F

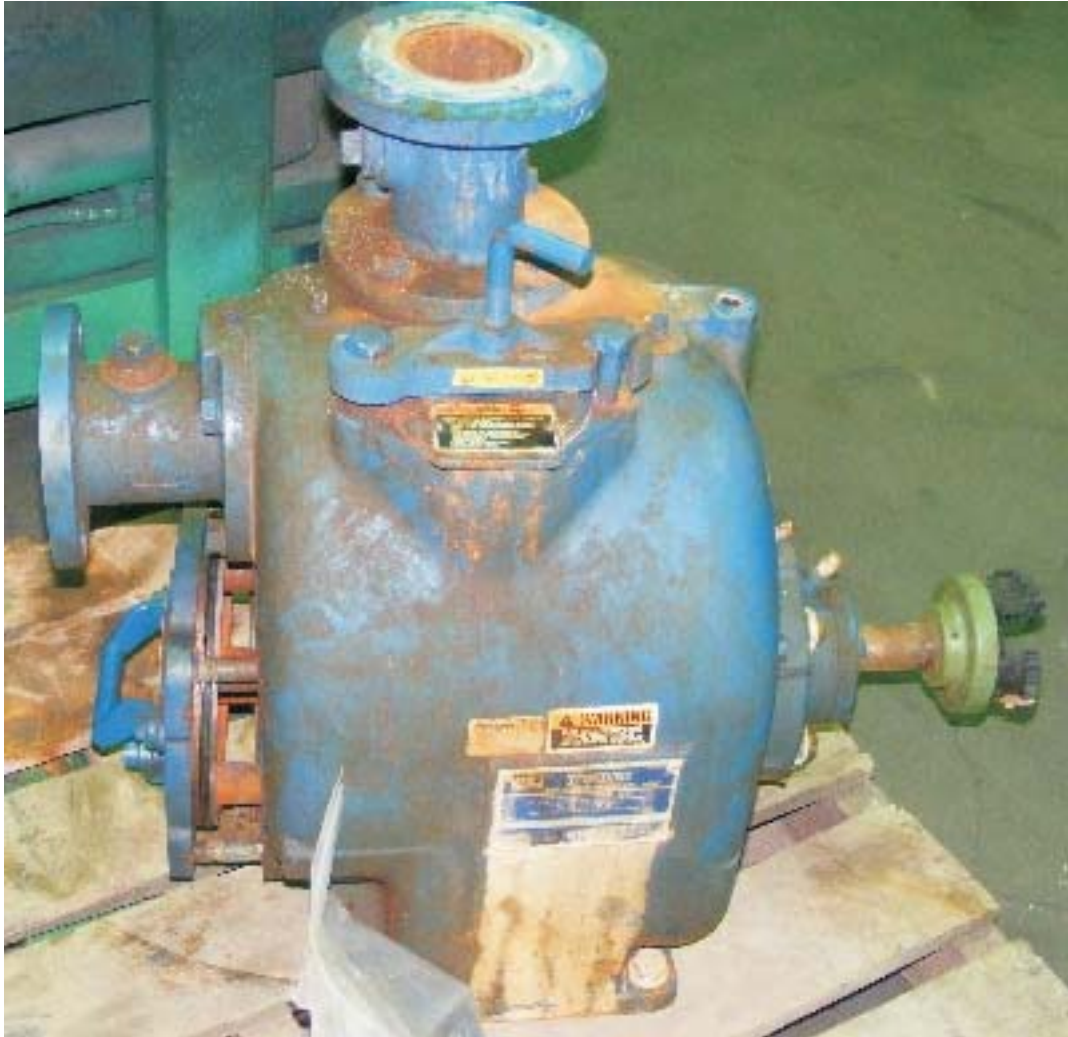
Pump on arrival at our shop.

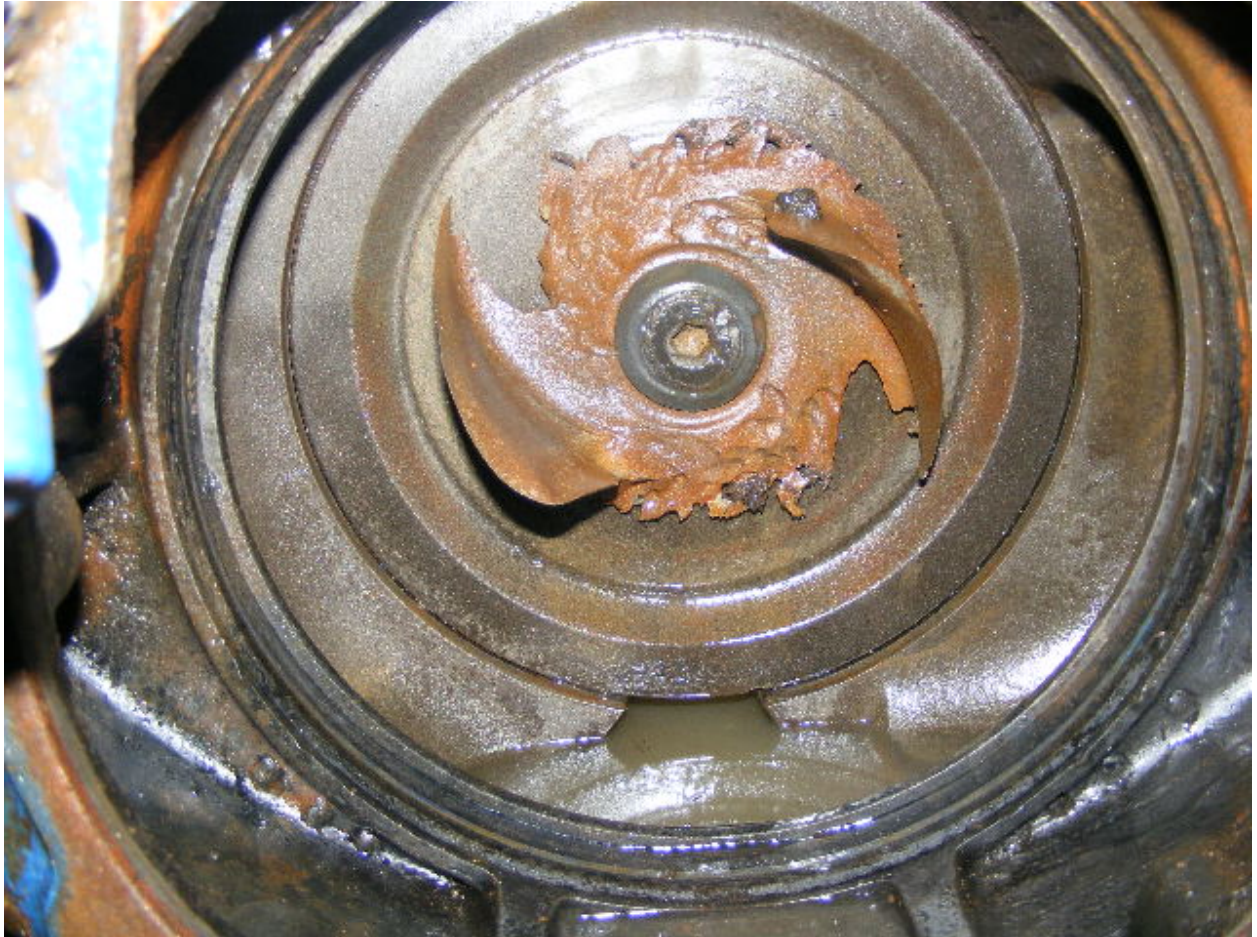
The pump shaft did turn freely when hand spun prior to disassembly. Upon disassembly we found the cast iron impeller with severe erosive and corrosive damage as can be seen in the photo below. The impeller will require replacement. The impeller will be upgraded from the standard cast iron to a corrosion and erosion resistant stainless steel. This is impeller upgrade should extend the impeller life.

The impeller has suffered from erosion wear and possible chemical corrosion.

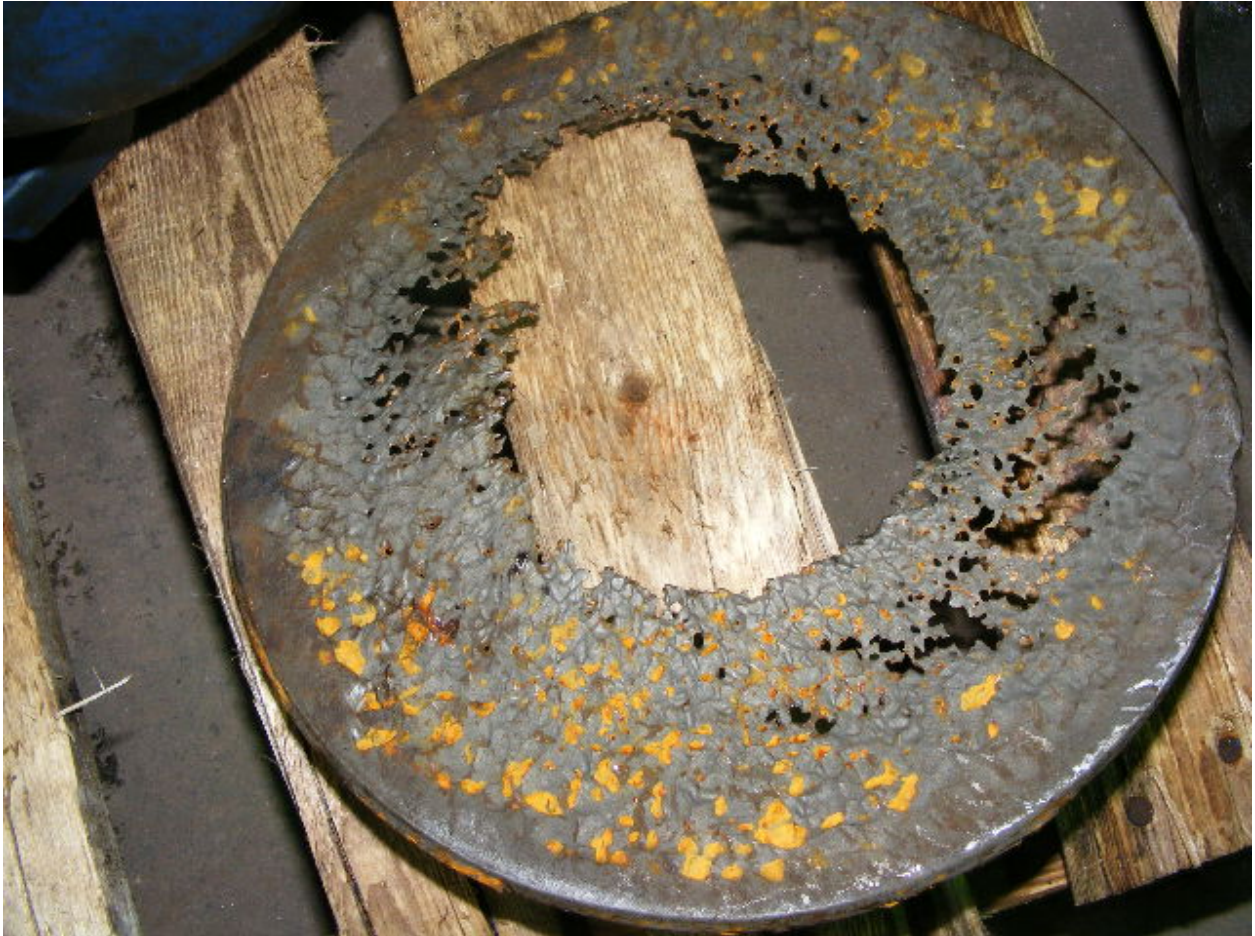
We received the pump contaminated with process fluid. A thorough inspection of the unit was conducted. The exterior of the pump was found to be in generally good condition. The wear plate is extensively worn from what we suspect is erosion due to the nature of the fluid being pumped and the wear being accentuated by the high velocities that exist were the impeller vanes run in close proximity to the wear plate. In an effort to extend the life of the wear plate it will be upgraded from standard carbon steel to a corrosion and erosion resistant stainless steel.

The process fluid and high velocities have eroded the wear plate. The wear plate will be replaced with one that will better withstand the effects of erosion.

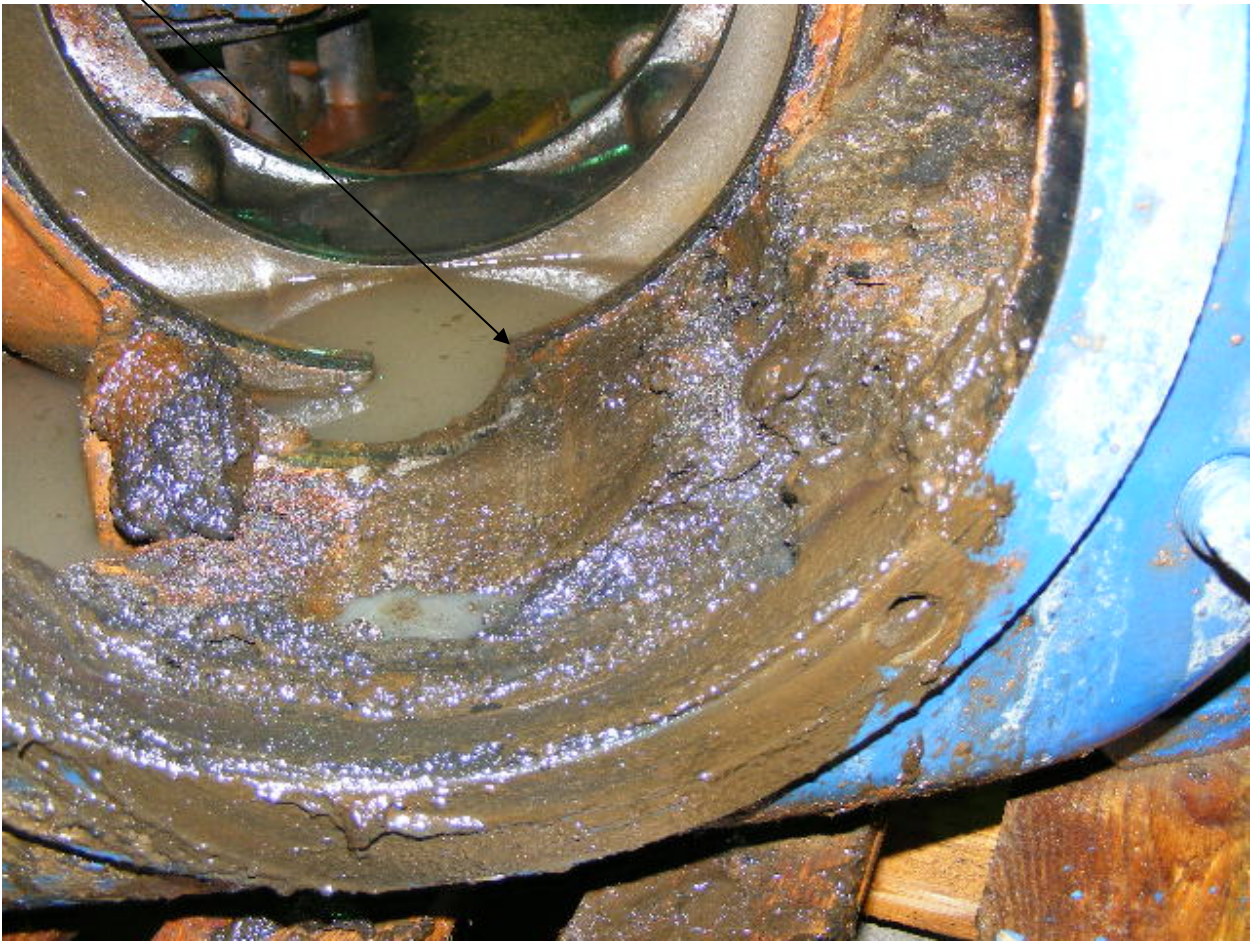
The casing has some internal erosive/corrosive wear. It is difficult to see it in the photo below. The casing suitable for reuse.

The wear in this area is not bad. This casing is in relatively good condition given the service.

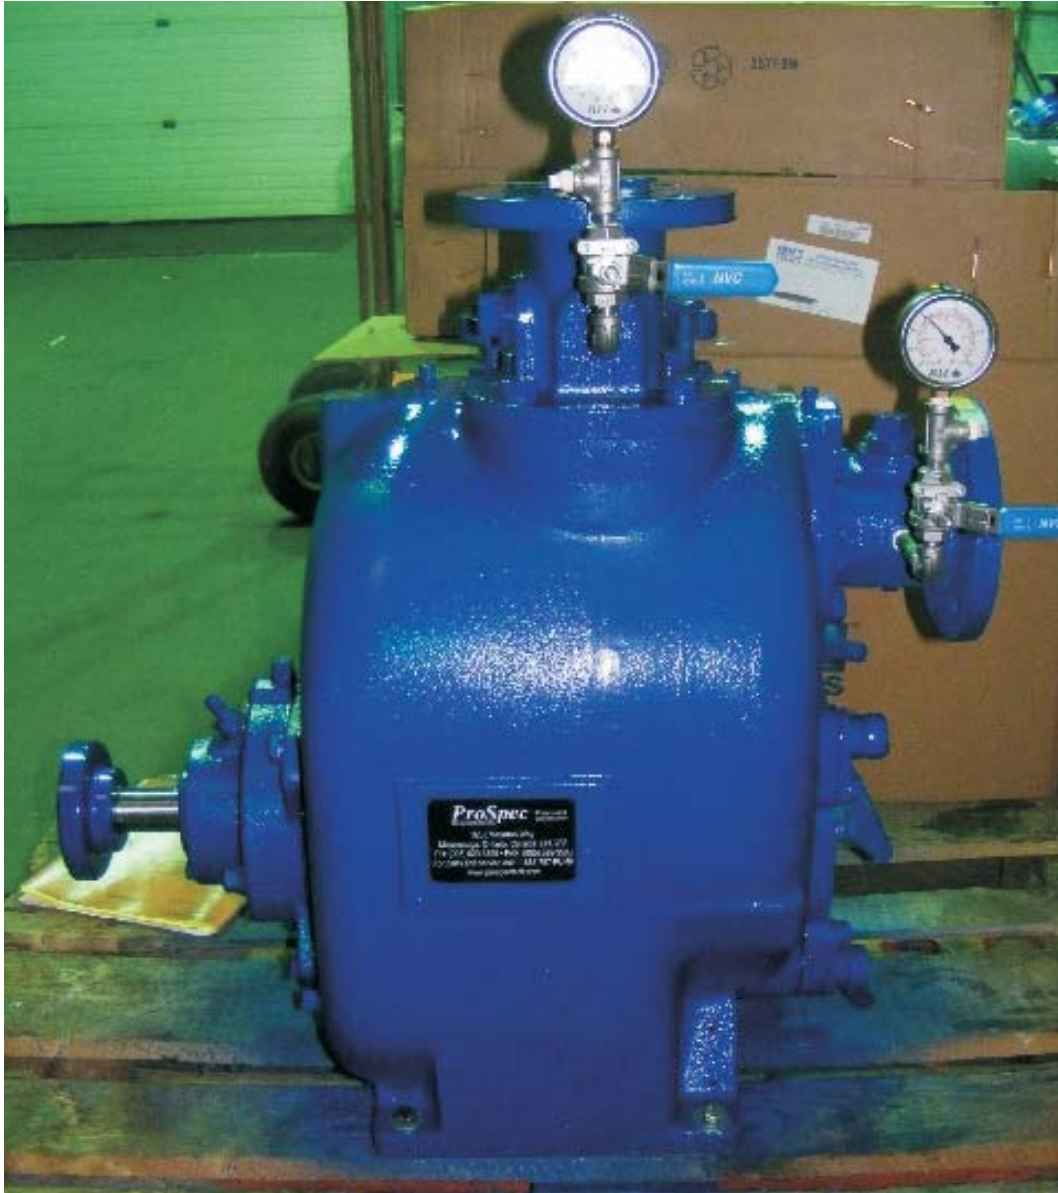
Completed repair.
