EQUIPMENT REPAIR REPORT

Our Reference: Sales order #5000004890

Subject: Goulds Pump Repair

Model: 3410M

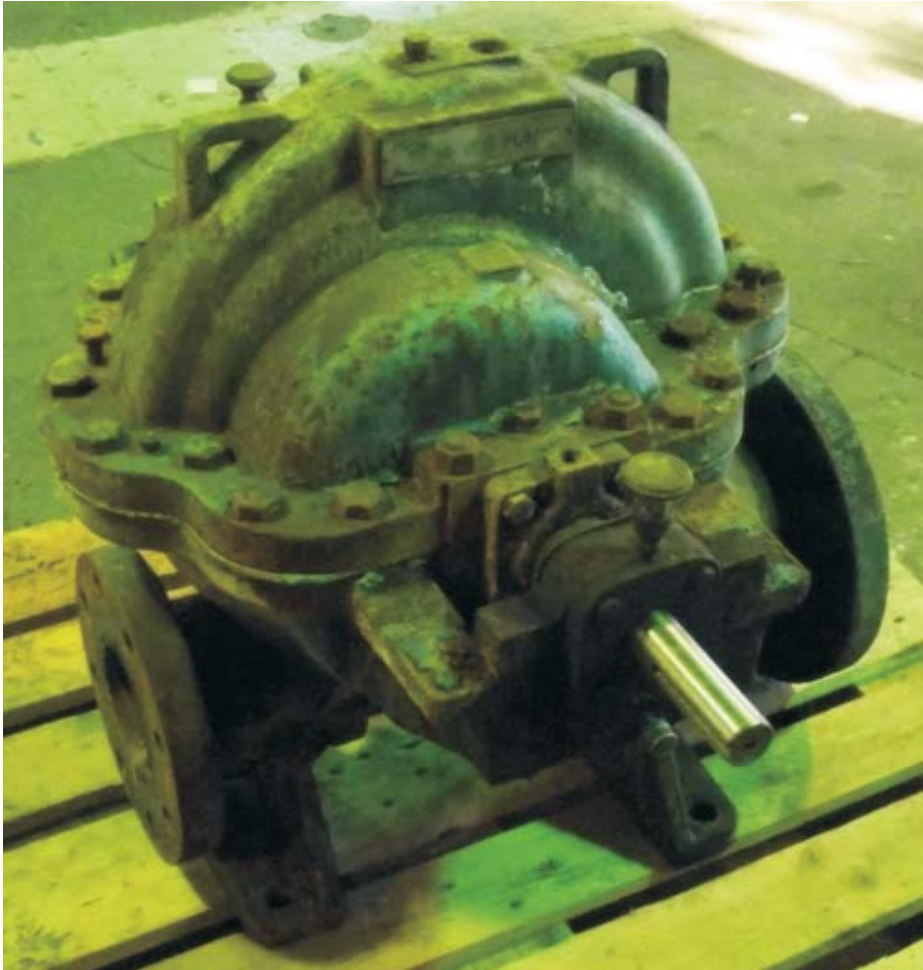
Upon receipt a thorough inspection of the unit was conducted. The exterior of the pump was found to be in generally good condition with corrosion in areas where the finish coat had been removed or damaged. Casing feet, bearing housing arms, flanges and casing mating half surfaces were in very good condition. The pump interior was again found to be in good condition with only surface rust and the occasional flaked area with major corroded areas. The critical area around cutwater was in quite good condition and would require no repair or material addition.

Pump as it arrived at our shop.

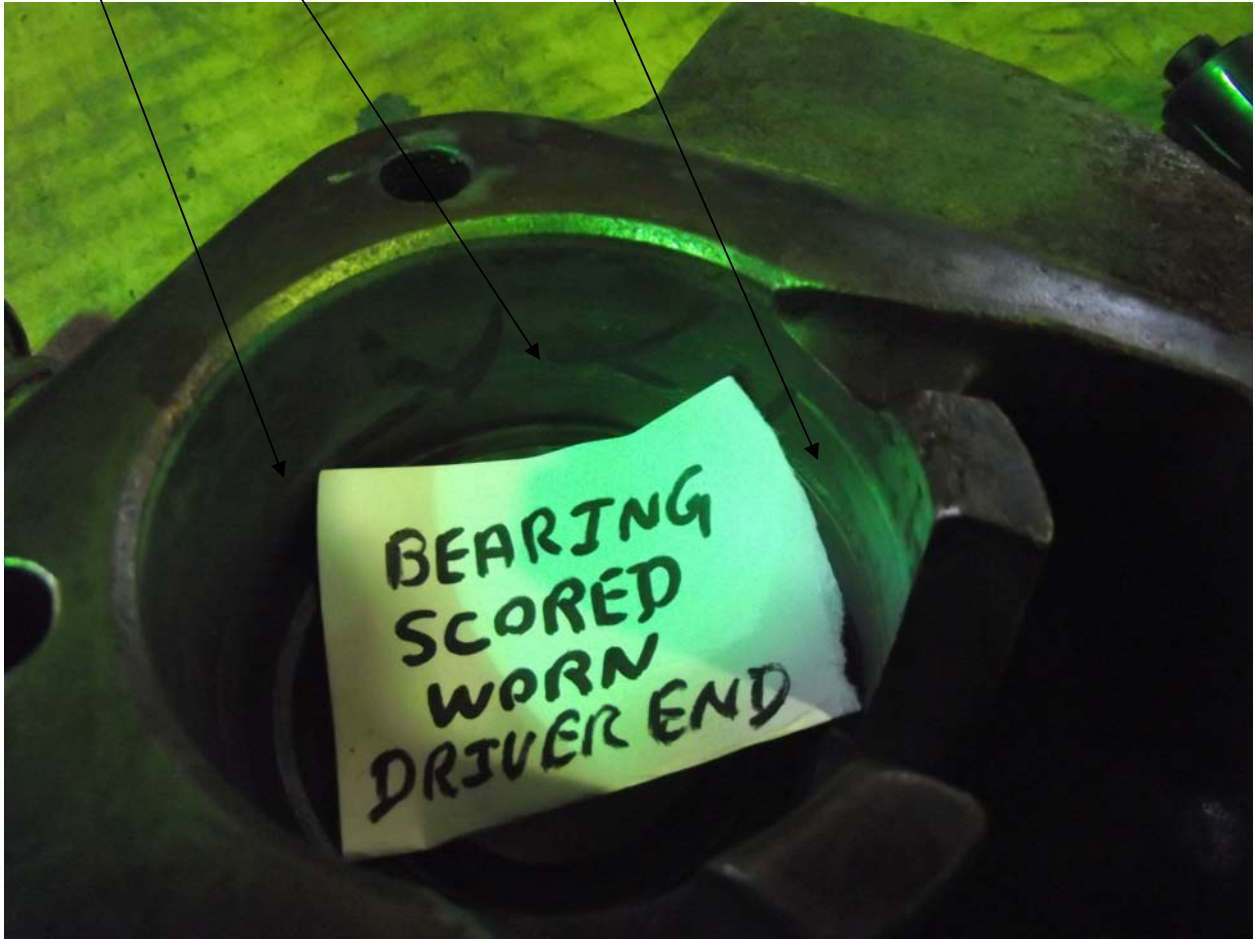
The drive end bearing housing (134) was scored under the bearing which indicates that the outer race of the bearing may have rotated in the housing. We measured the diameter at this point and recorded it as 2.835" at one location and 2.842" at second location. This housing will be replaced.

The bearing frame (134) on the drive end is scored.

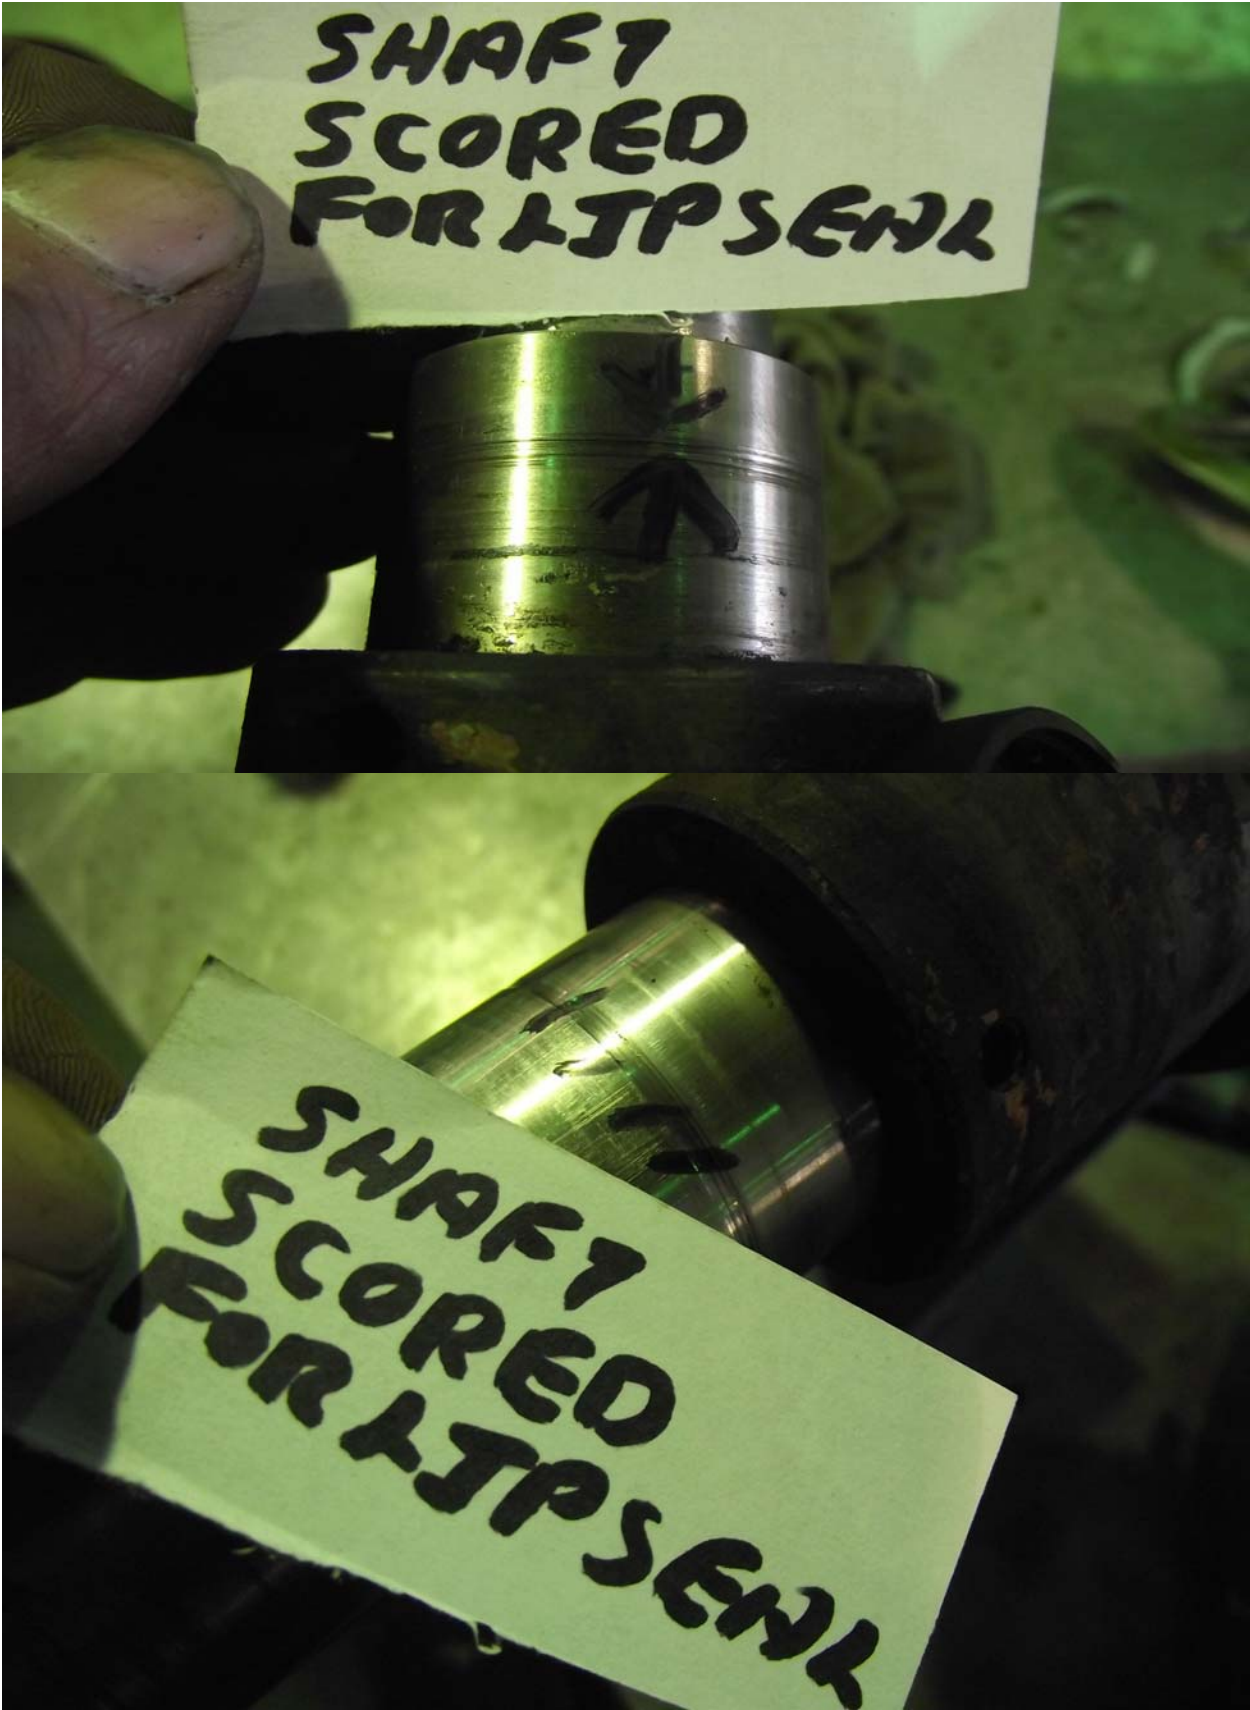
We measured the shaft run out at the location indicated in the drawing below. The shaft is straight and does not require replacement however it is grooved at the locations indicated below. We will chrome the shaft at these locations to provide leak free operation at the bearing frame lip seals.

The shaft is grooved at the location where the lip seals run.

- Chrome the shaft at the required points.
- Balance the rotating element
- Reassemble the pump with a driven side housing, new mechanical seals, new bearings, bearing lock nuts, bearing lock nut washers, oil seals, keys, constant level oilers, shaft sleeves, shaft sleeve nuts, flush lines

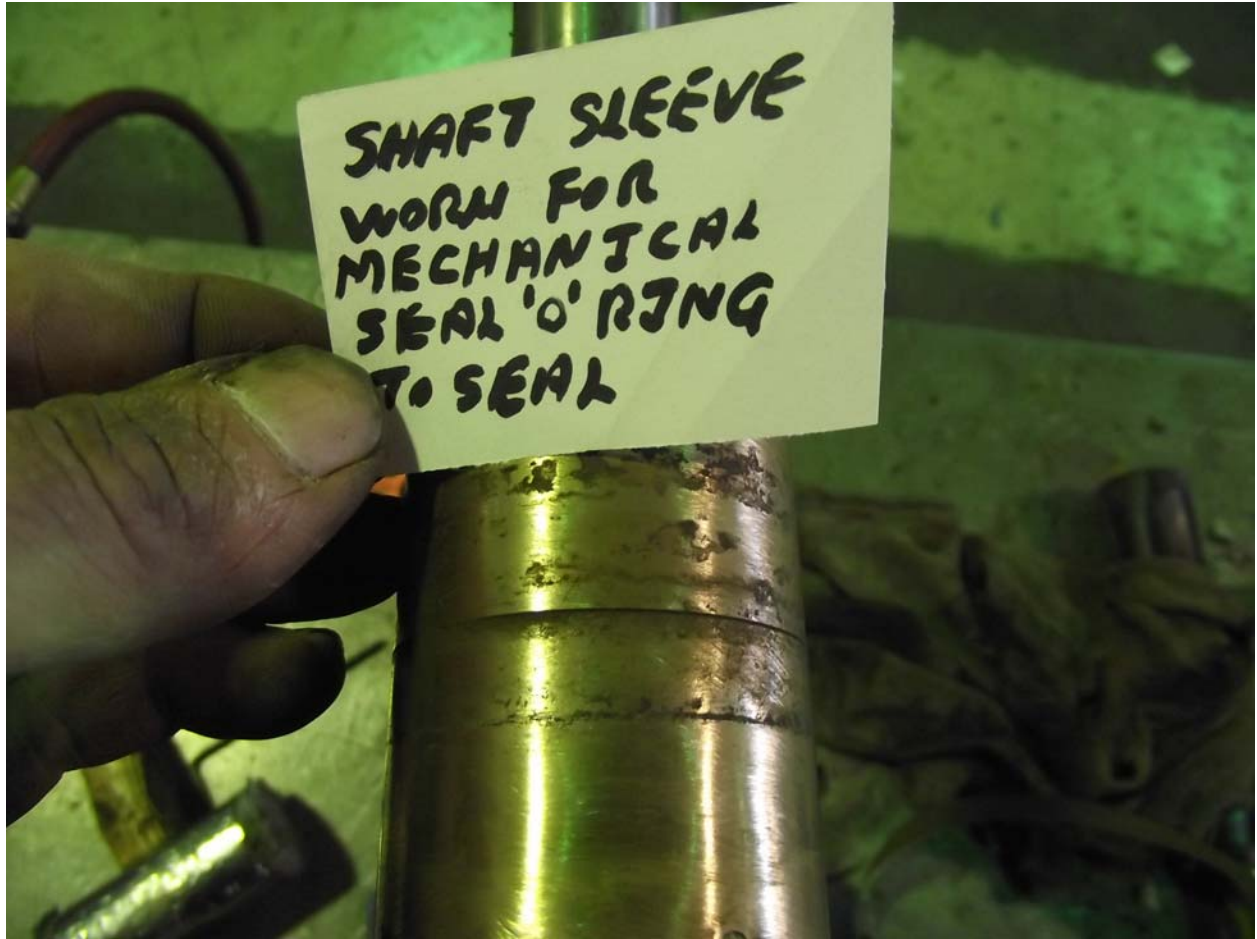
The shaft sleeves (126) are grooved and worn as can be seen in the photo below. In order to ensure a proper seal at the o-ring in the mechanical seal the sleeves require replacement.

The shaft sleeves are grooved and worn at the location of mechanical seal.

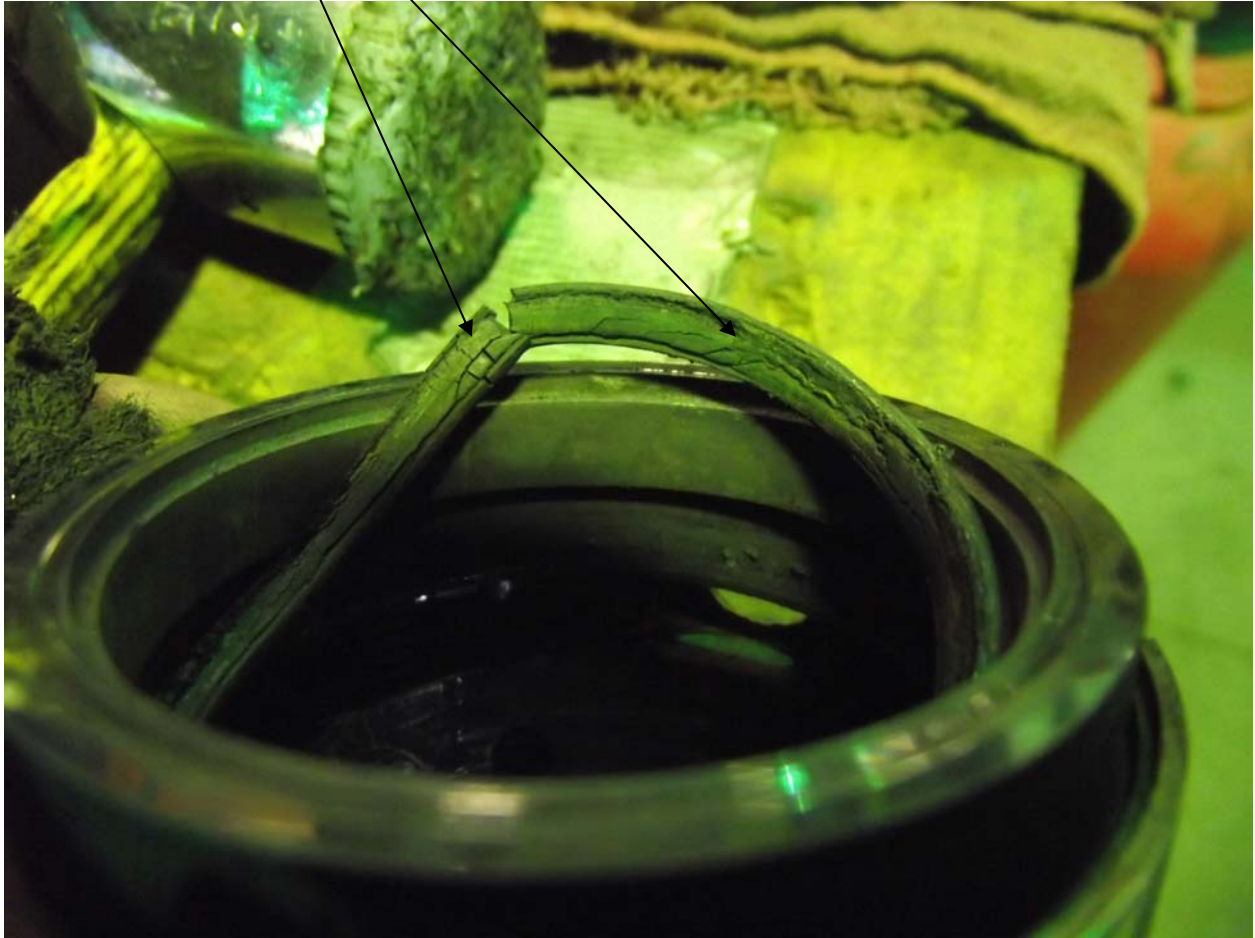
The mechanical seals may have been operational without sufficient process fluid lubrication. The seal faces were cracked and very polished which is an indication that they were running very hot. The o-rings as can be seen in the photo were very cracked and very brittle. The cracked o-ring is another sign of excessive heat at the seal. The mechanical seals require replacement. When this pump was first supplied in 1993 the mechanical seal was supplied with viton elastomers and carbon vs tungsten carbide faces. The pump as we assessed it had tungsten carbide vs tungsten carbide faces. In an effort to ensure you are getting sufficient life from the seals we should review the system conditions prior to proceeding with a repair to ensure we have the correct seal faces and elastomer material. If the fluid is boiler feed water then carbon vs silicon carbide with EPDM would work best.

We noticed that the flush lines were missing when we received the pump. These lines are required and have been included for in the quotation below. If the pump is in operation on a suction lift and these lines were not in use then the seals may not have been lubricated properly.

The mechanical seals may have been operating without process fluid lubrication. The o-rings are hard and brittle.

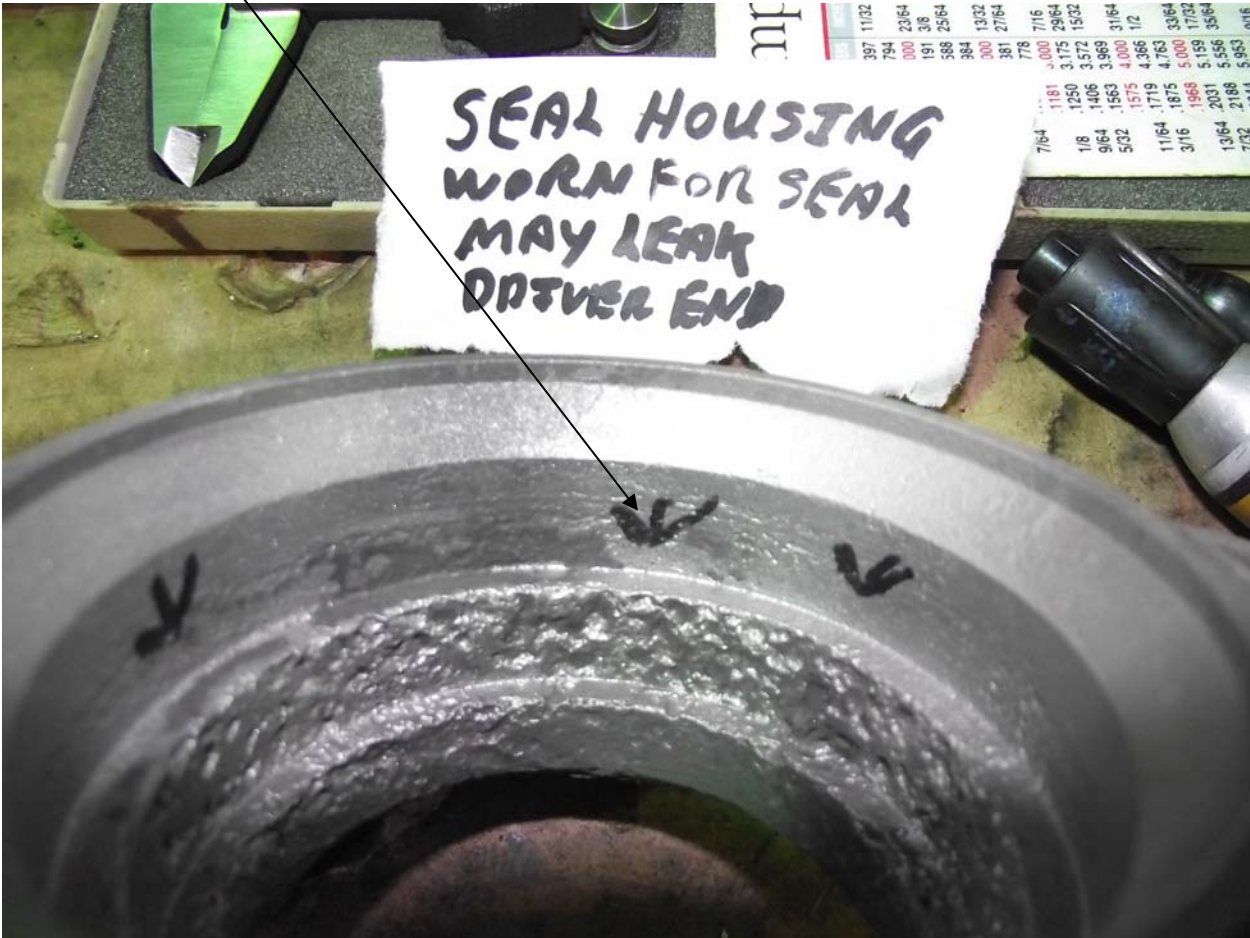
The glands are eroded at the point that the mechanical seal o-rings mate with the gland. The glands pictured below require replacement.

The glands have eroded in the area of the O-rings.

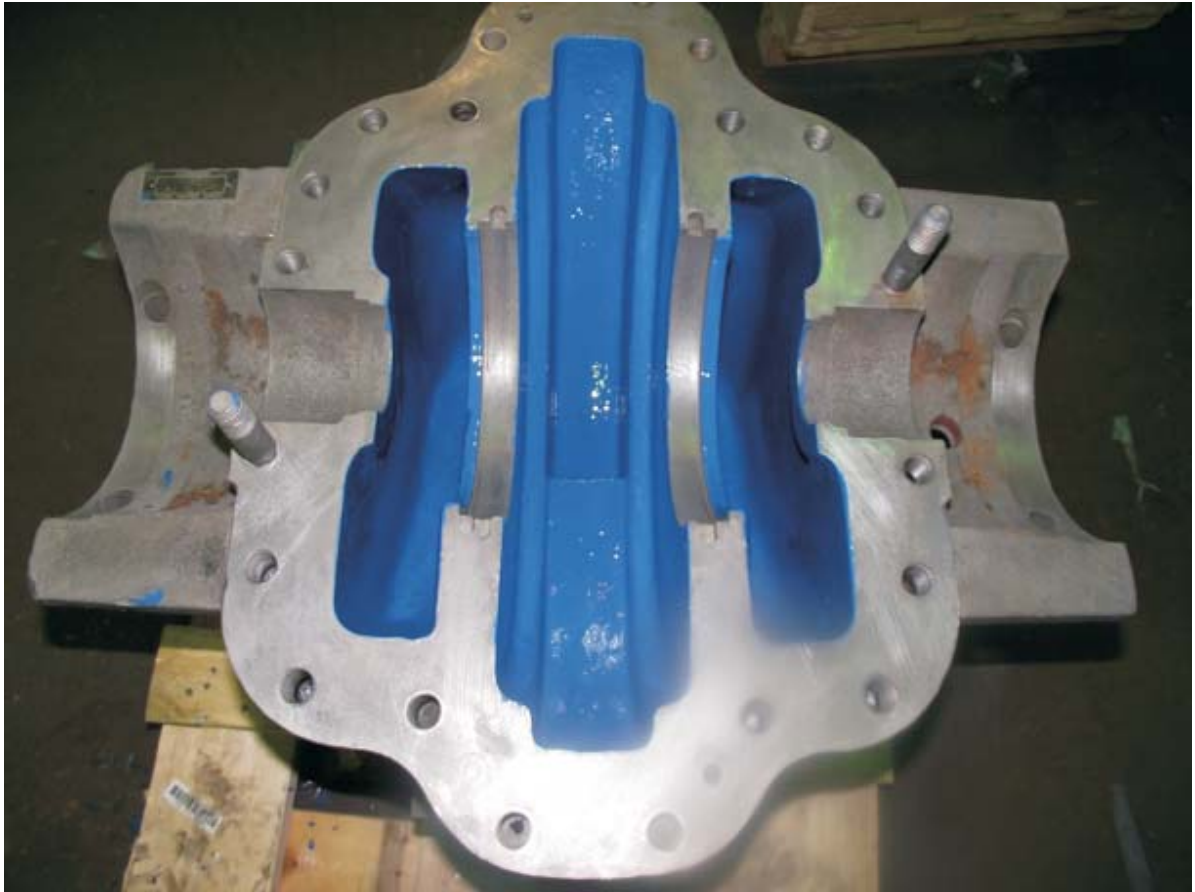
Coating applied on lower casing.

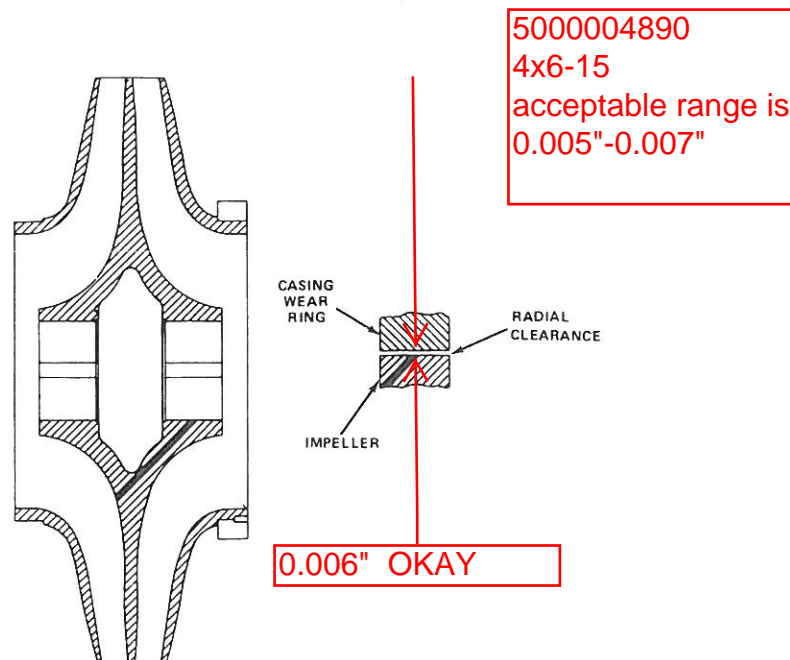
Figure 3-5

The impeller and wear rings were in good condition. We measured the radial clearance at 0.006” and recorded it in the diagram below. This clearance is acceptable and the impeller and wear rings are suitable for reuse.

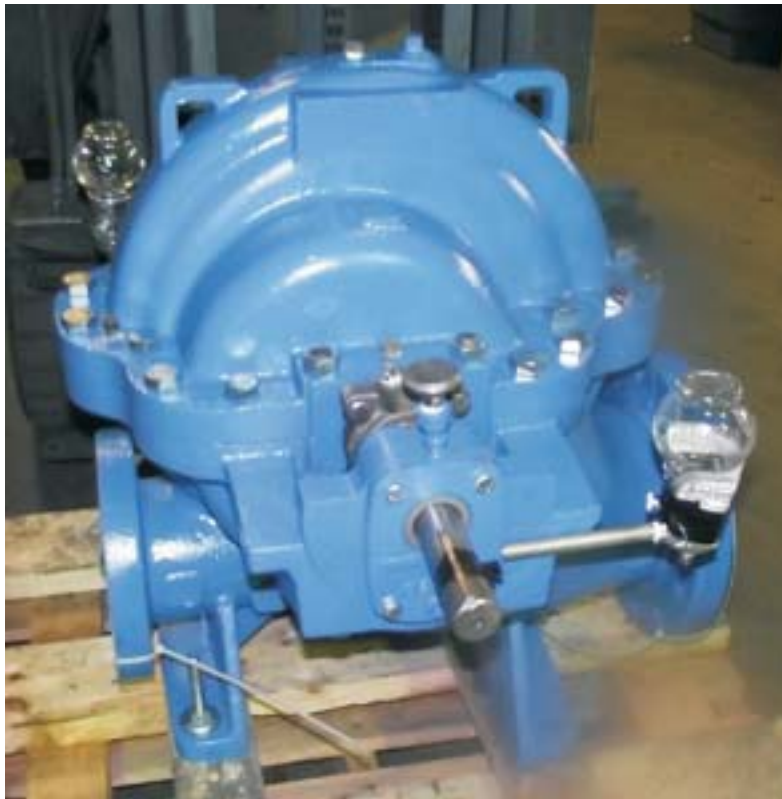
Completed repair.
