EQUIPMENT REPAIR REPORT

Our Reference: SO 5000002990

Subject: Repair Quotation for Model: VIC 14 x 24 CHC

Model: VIC 14 x 24 CHC

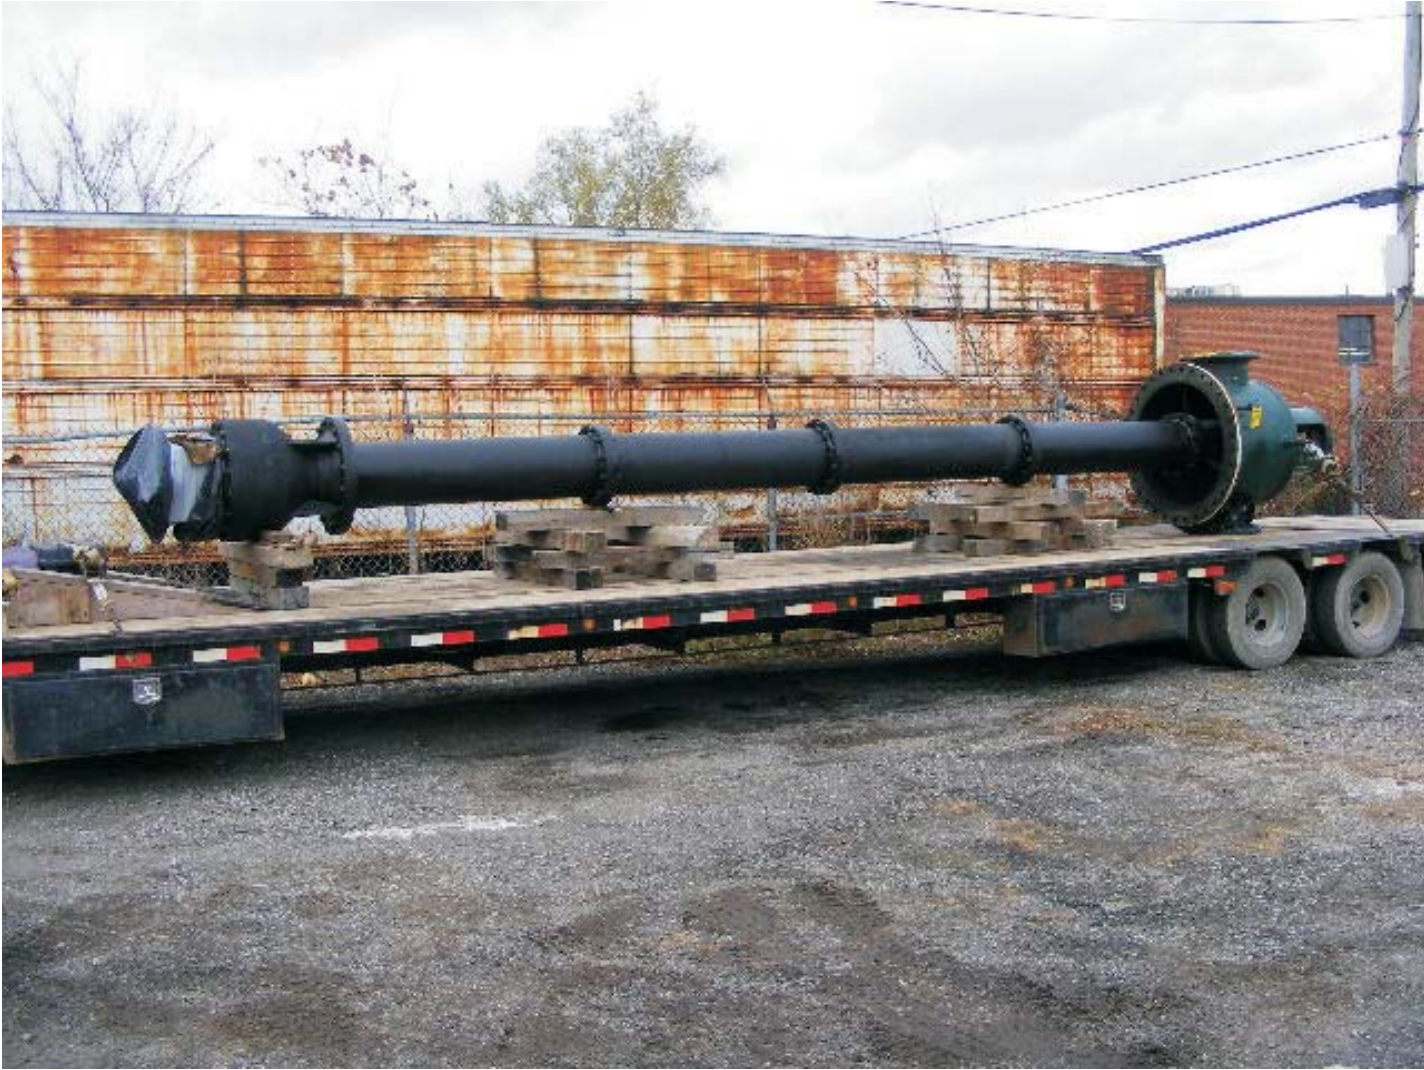
The pump was received less motor, coupling and less mechanical seal. Upon receipt we conducted a manual rotational test and found that the pump shaft rotated freely. The exterior of the unit was in very good condition with minimal rust and oxidation. The pump was dismantled and we proceed to do our measurements.

Pump as it arrived at our shop.

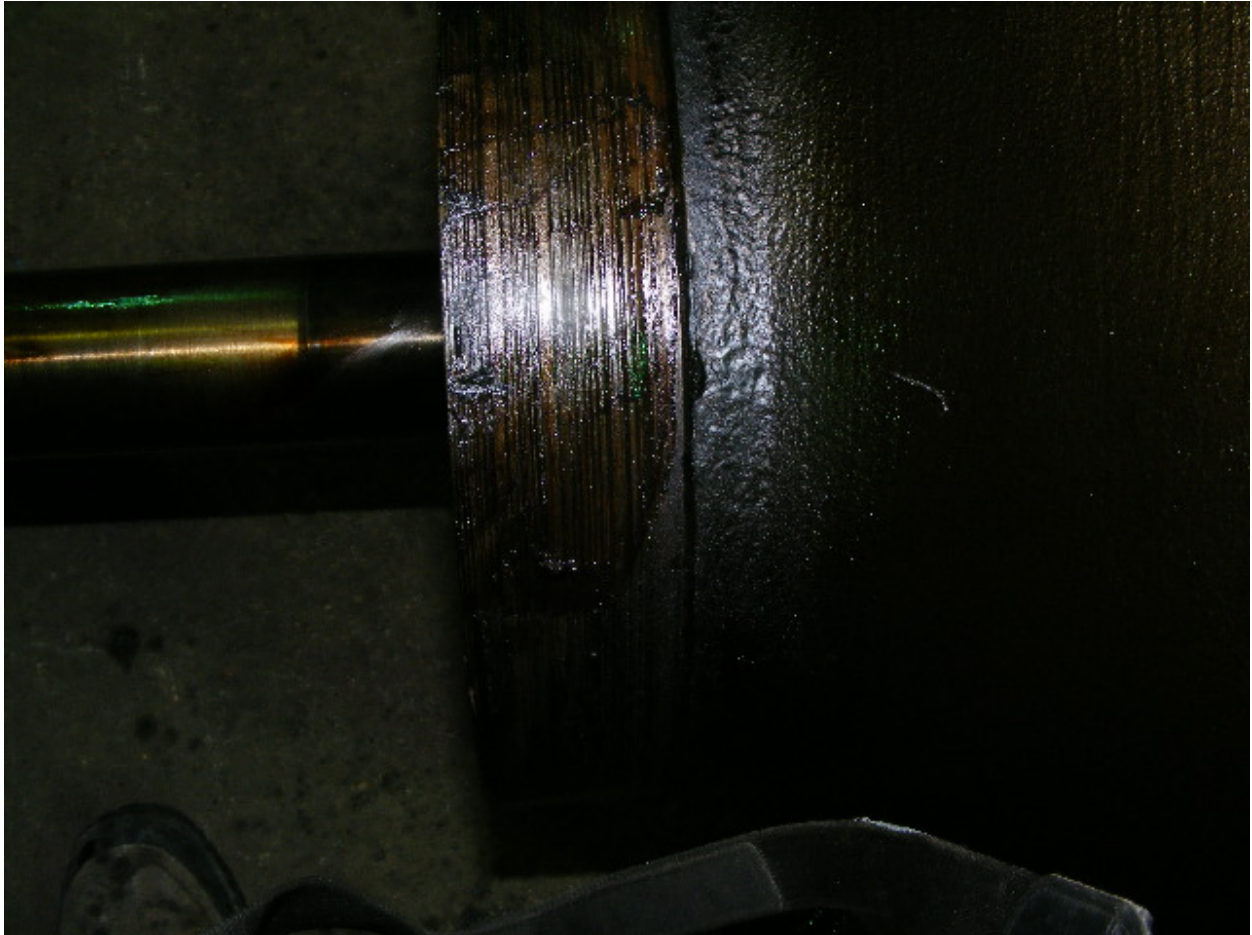
The wood found in the impeller did not damage the impeller in any way. The shaft has minimal wear at the bearing however this area will be chromed and ground to size.

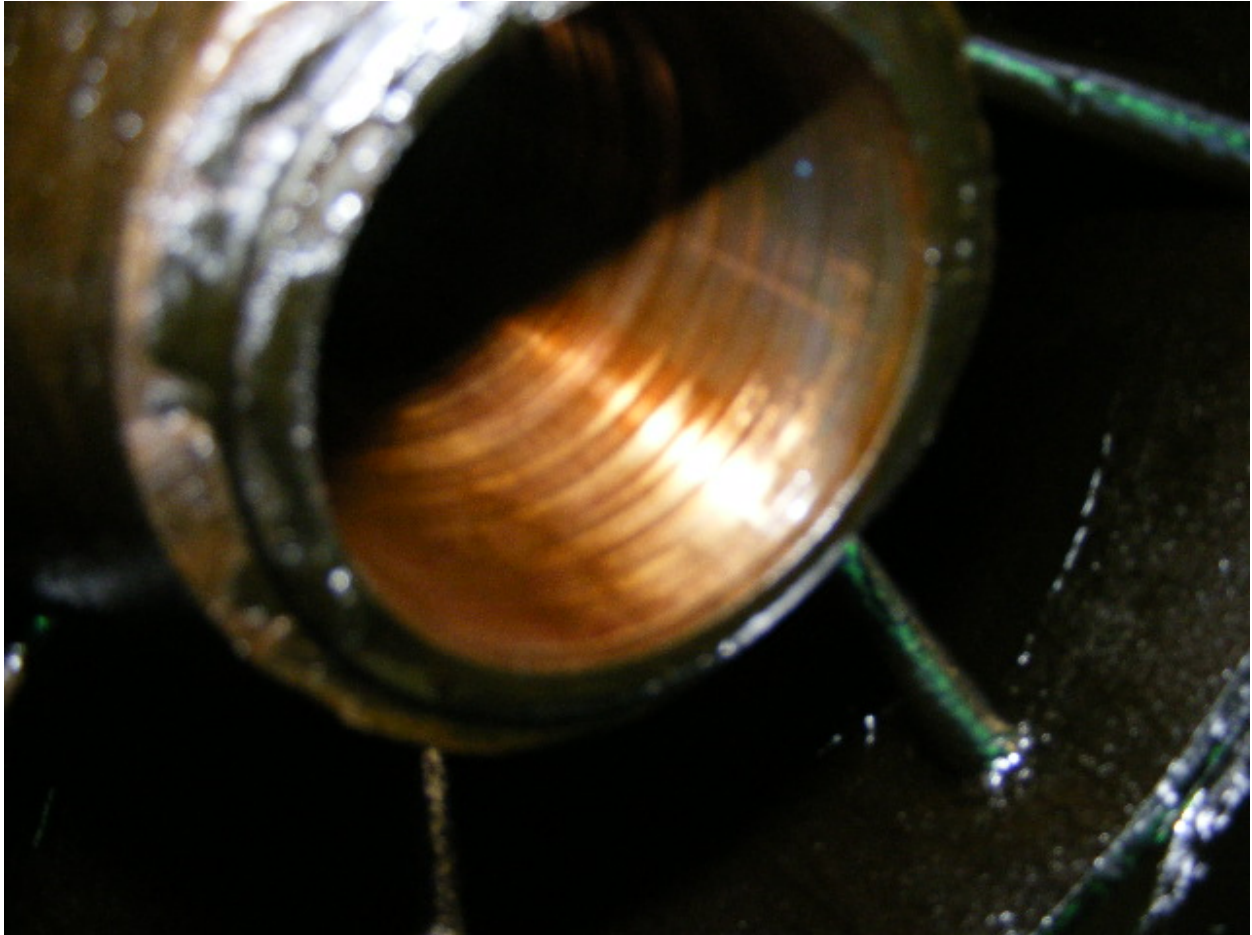
Impeller wear at the bowl contact area is even all around.

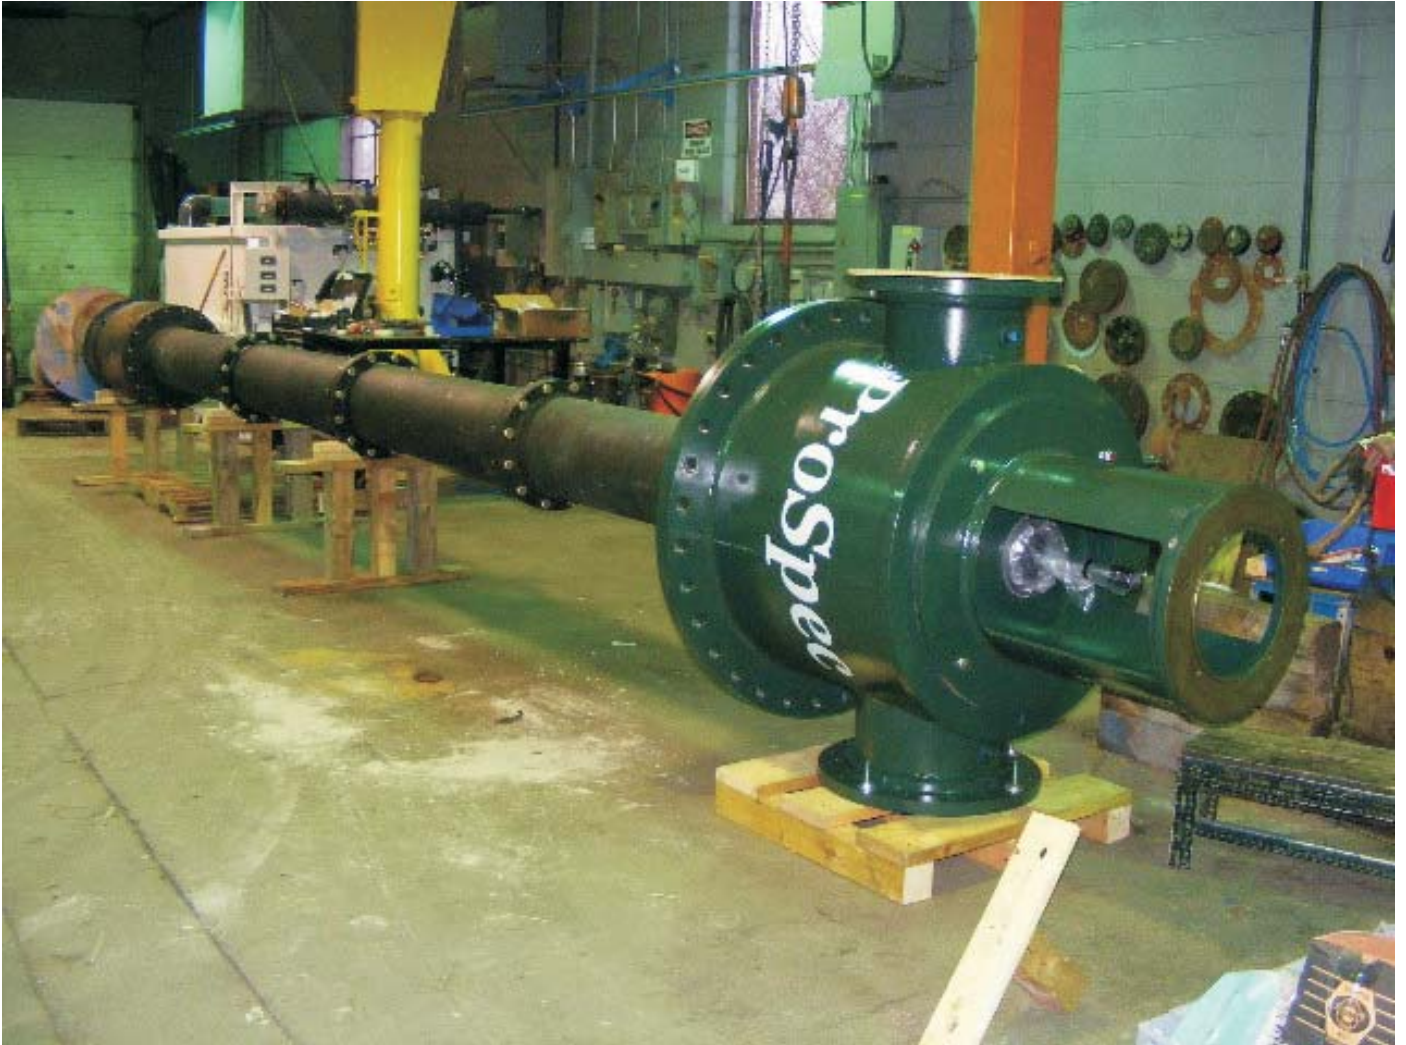
Completed repair.
