EQUIPMENT REPAIR REPORT

Our Reference: 5000003874

Subject: Gorman Rupp Model S8B1 575 volt 100 hp
W/ 16 inch diameter impeller

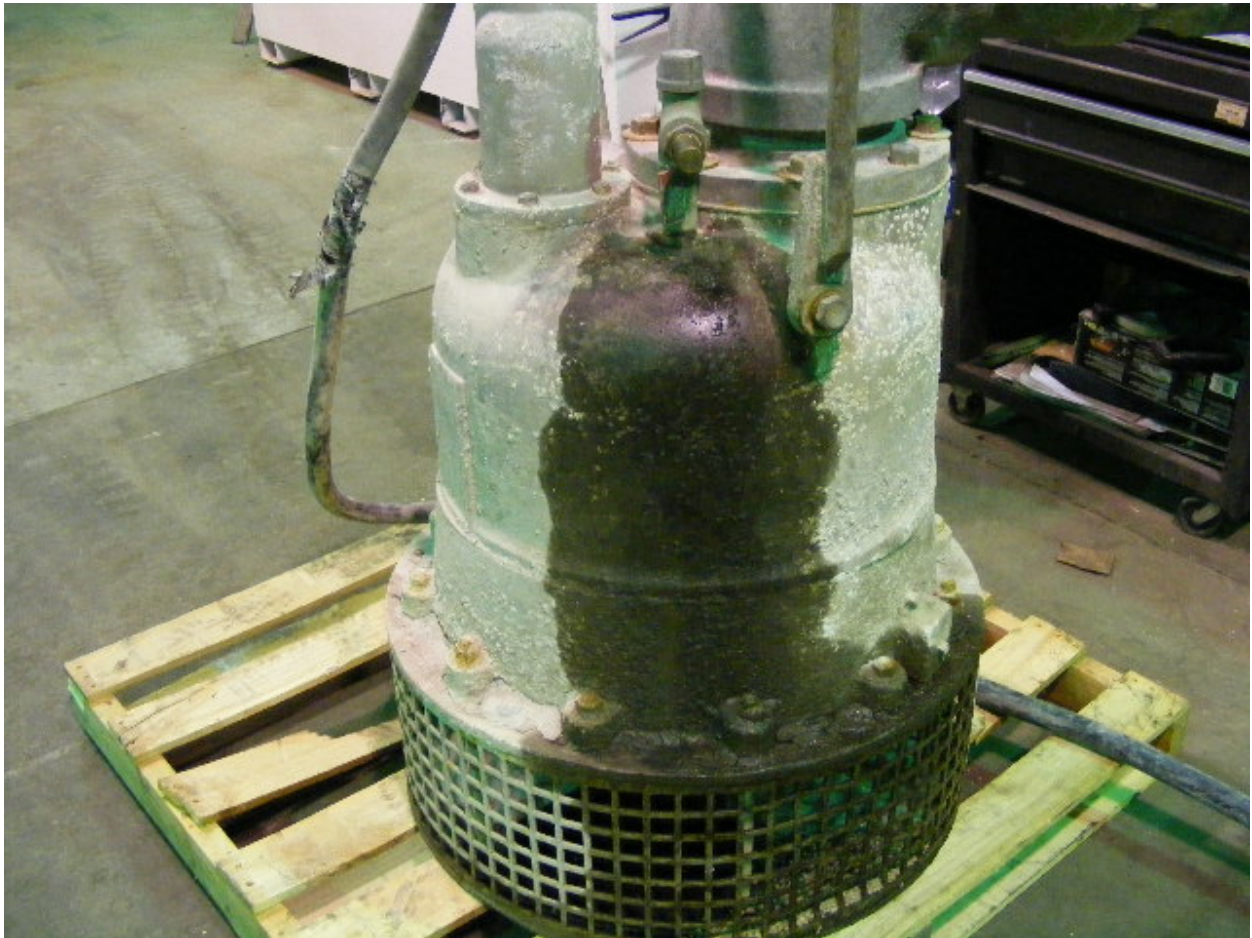
The power cable has been breached which produced an entry point for water. We have attached a photo of this area below. The electrical tape used to prevent water from entering the pump did not work. It appears that the failure was due to the water entering the terminal board area and shorting out one of the terminals.

The power cable was cut and tapped.

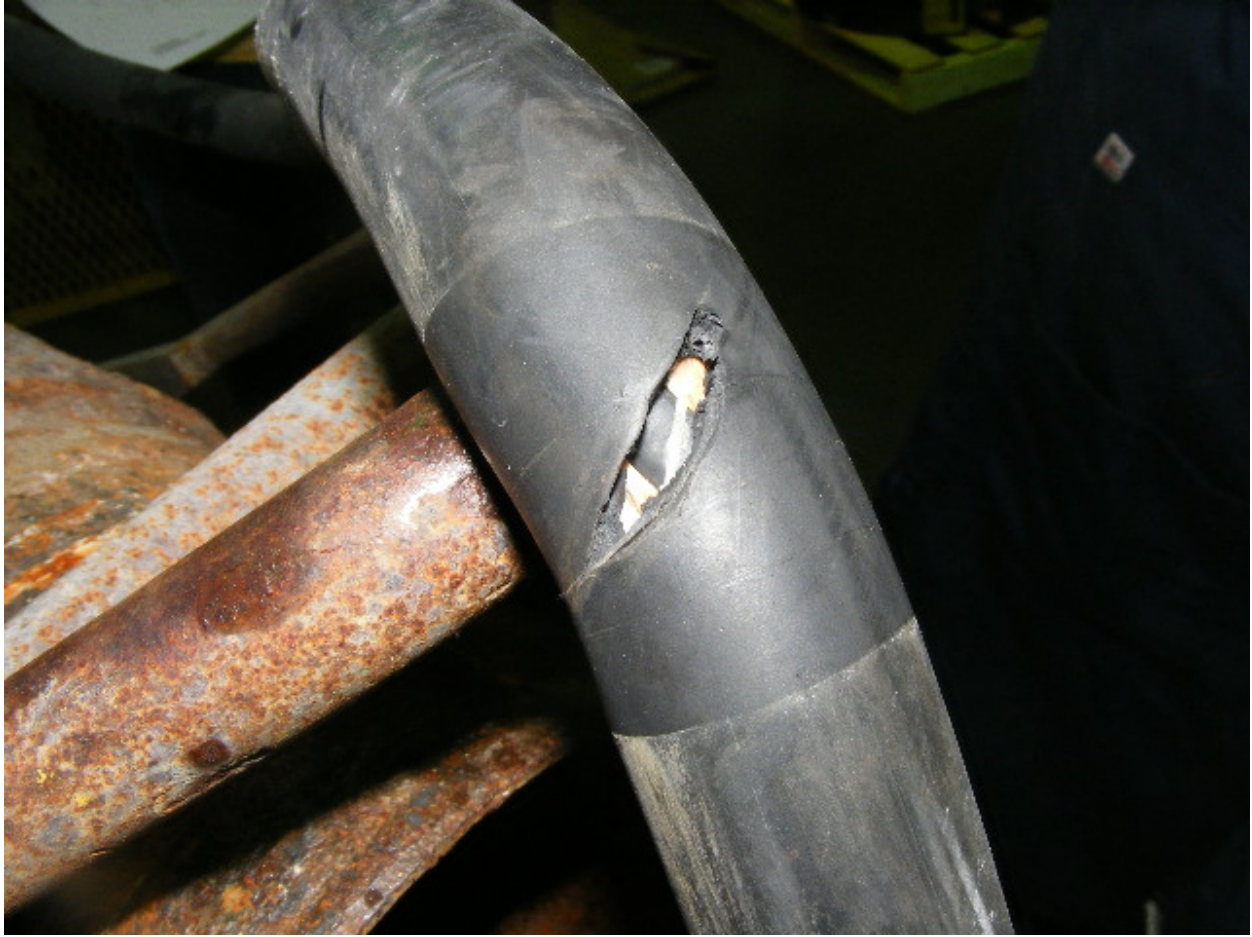
Upon receipt a thorough inspection of the unit was conducted. The exterior of the pump was found to be in generally good condition with some pitting corrosion over the entire pump housing. The strainer was bent but can be repaired. Prior to disassembly we conducted an air test at 7 psi (with soapy water) on the stator housing and found the air pressure leaking out through the splices in the electrical cord (seen in pictures two and three below).

The power cord leaked under a 7 psi air test.

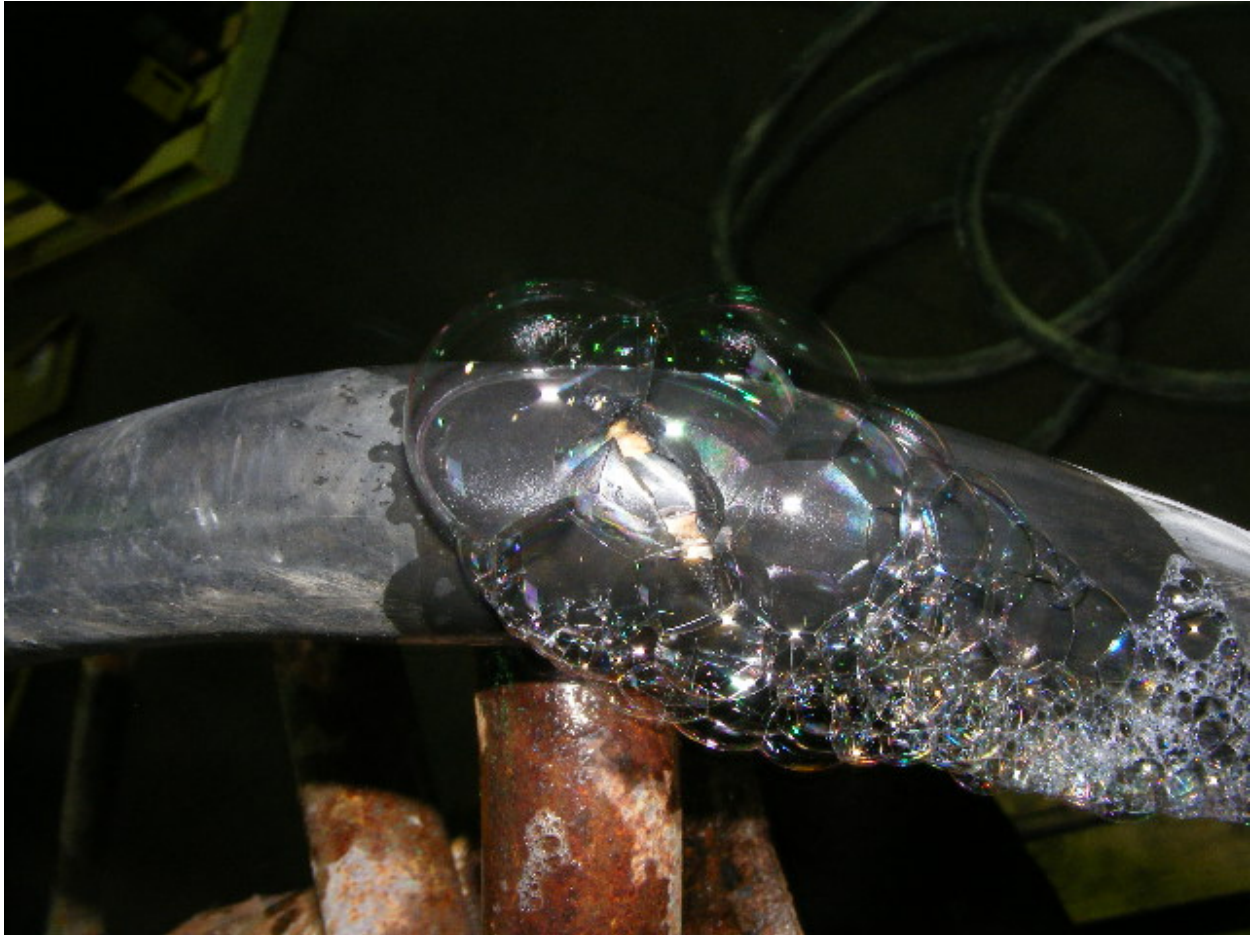
The power cord integrity has been breached

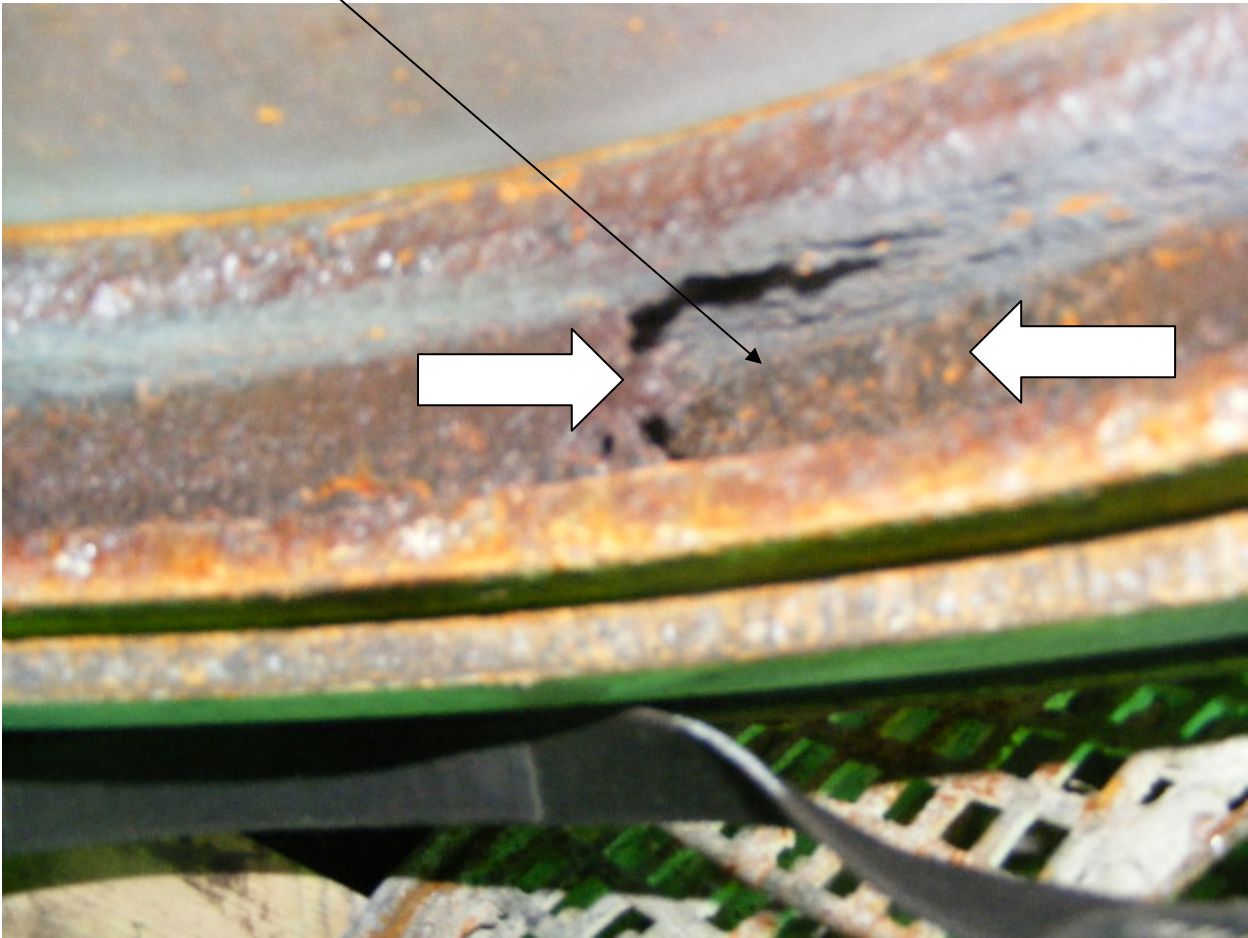
Completed repair at shipping.
